## General Information

| Make | Toyota | Model | Innova |
| YOM | 2022 | Mileage | 96,934 |
| Registration No. | NFE3732 | Chassis No. | PA2JA8EM1N0109179 |

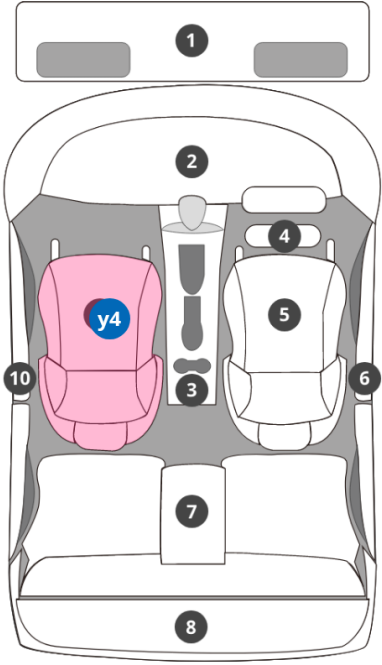
| Interior Evaluation : <span style="color: red;">C</span> | Exterior Evaluation : <span style="color: red;">E</span> |
|---|---|
| <b>Remarks</b><br>(L) Front Seat - Grime - Large | <b>Remarks</b><br>(R) Front Fender, Molding - Scratch & Dent - Medium / Front Bumper, Grille, Lamps - Scratch & Dent - Large / (R) Step, In-panel, Side Spoiler - Scratch & Dent - Large / (R) Rear Fender, Molding - Scratch & Dent - Large / (R) Rear Door, Molding - Scratch & Dent - Medium / (L) Rear Fender, Molding - Scratch & Dent - Small / Rear Bumper, Lamps, Panels - Scratch & Dent - Large / Trunk Hood, Rear Gate - Dent - Minimal / (L) Rear Door, Molding - Scratch & Dent - Large / (L) Step, In-panel, Side Spoiler - Scratch & Dent - Large / (L) Front Door, Molding - Scratch & Dent - Large / (L) Front Fender, Molding - Scratch & Dent - Large / (R) Mirror - Scratch - Minimal / Roof - Scratch - Minimal |
