## General Information

<b>Make</b>	Toyota	<b>Model</b>	Veloz
<b>YOM</b>	2025	<b>Odo Meter Reading</b>	5,030
<b>Registration No.</b>	NKN7149	<b>Chassis No.</b>	MHFAB1BY5R3128158
<b>CC</b>	1.5	<b>Transmission</b>	CVT
<b>Fuel Type</b>	Gas	<b>Type of Body</b>	Wagon
<b>Colour</b>	Red

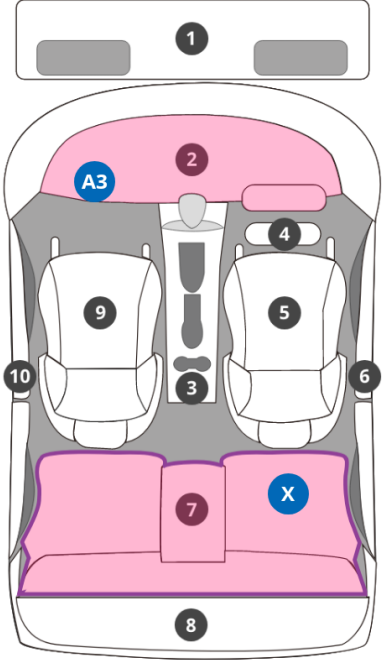
<b>Interior Evaluation :</b> <span style="float: right;"><b>B</b></span>	<b>Exterior Evaluation :</b> <span style="float: right;"><b>B</b></span>

<b>Inspector Notes</b>	
With LTO plate and Sparetire and Warranty booklet, No Tools and Jack, No wiper arm, rear seat missing, warning lamps on airbag, steering wheel replaced,

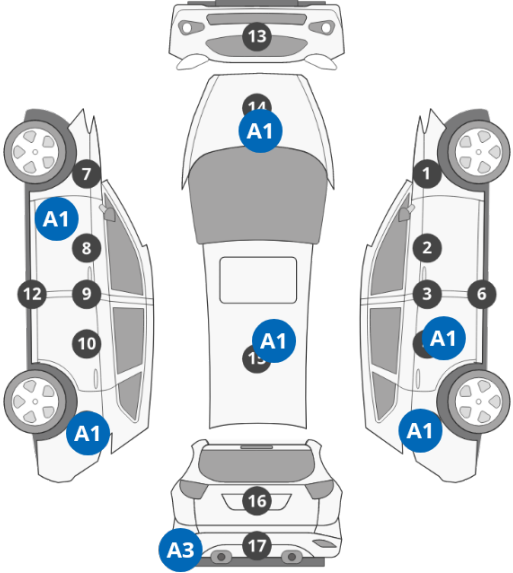
<p><b>A</b> : Scratch <b>AU</b> : Scratch &amp; Dent <b>B</b> : Modified <b>C</b> : Corrosion <b>G</b> : Stone chip <b>P</b> : Faded <b>S</b> : Rust <b>SC</b> : Rust &amp; Corrosion <b>U</b> : Dent <b>X</b> : Defective <b>Y</b> : Crack, Gap</p>
<b>Remarks</b> Rear Seat - Missing - Yes / Steering Wheel - Worn, Peel, Crack - Medium	<b>Remarks</b> Rear Bumper, Lamps, Panels - Scratch - Medium / (L) Rear Fender, Molding - Scratch - Minimal / (L) Front Door, Molding - Scratch - Minimal / Bonnet, Headlight - Scratch - Minimal / Roof - Scratch - Minimal / (R) Rear Door, Molding - Scratch - Minimal / (R) Rear Fender, Molding - Scratch - Minimal
