## General Information

<b>Make</b>	Toyota	<b>Model</b>	Alphard
<b>YOM</b>	2017	<b>Odo Meter Reading</b>	40,425
<b>Registration No.</b>	NAE8884	<b>Chassis No.</b>	JTNGK3DH0G8015812
<b>CC</b>	3.5	<b>Transmission</b>	CVT
<b>Fuel Type</b>	Gas	<b>Type of Body</b>	Van
<b>Colour</b>	White

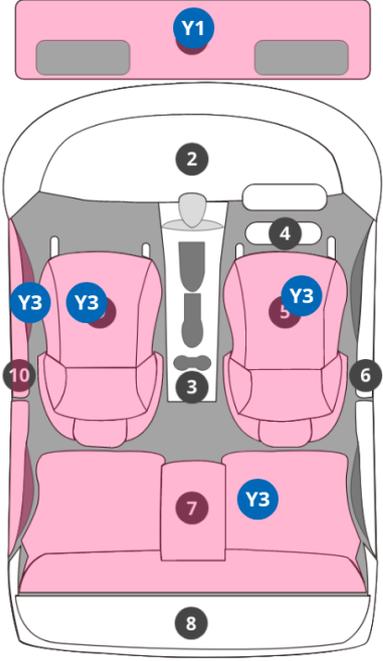
<b>Interior Evaluation :</b> <span style="float: right;"><b>B</b></span>	<b>Exterior Evaluation :</b> <span style="float: right;"><b>C</b></span>

<p><b>a</b> : Cut, Fray <b>d</b> : Loose, Deformed <b>k</b> : Animal Hair <b>s</b> : Smell <b>t</b> : Cigarette Burns <b>x</b> : Defective <b>y</b> : Stain</p>

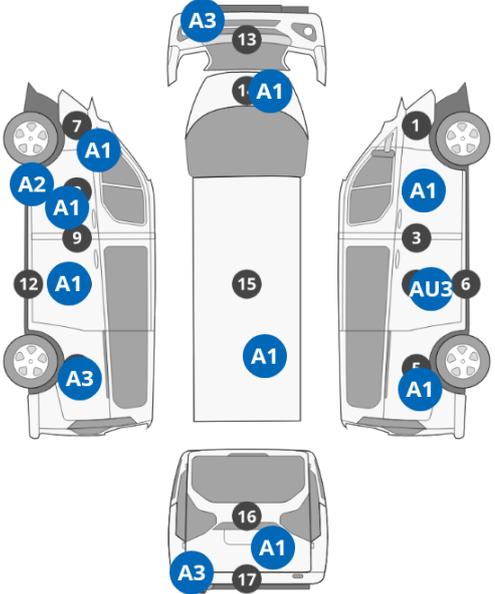
<p><b>A</b> : Scratch <b>AU</b> : Scratch &amp; Dent <b>B</b> : Modified <b>C</b> : Corrosion <b>G</b> : Stone chip <b>P</b> : Faded <b>S</b> : Rust <b>SC</b> : Rust &amp; Corrosion <b>U</b> : Dent <b>X</b> : Defective <b>Y</b> : Crack, Gap</p>
<p><b>Remarks</b> (R) Front Seat - Grime - Medium / Rear Seat - Grime - Medium / (L) Front Seat - Grime - Medium / (L) Front Trim - Grime - Medium / Ceiling - Grime - Minimal</p>	<p><b>Remarks</b> (L) Rear Fender, Molding - Scratch - Medium / Trunk Hood, Rear Gate - Scratch - Minimal / Rear Bumper, Lamps, Panels - Scratch - Medium / (R) Rear Door, Molding - Scratch &amp; Dent - Medium / (R) Front Door, Molding - Scratch - Minimal / Front Bumper, Grille, Lamps - Scratch - Medium / (L) Mirror - Scratch - Minimal / (L) Step, In-panel, Side Spoiler - Scratch - Small / (L) Front Door, Molding - Scratch - Minimal / (L) Rear Door, Molding - Scratch - Minimal / (R) Rear Fender, Molding - Scratch - Minimal / Bonnet, Headlight - Scratch - Minimal / Roof - Scratch - Minimal</p>
