## General Information

<b>Make</b>	Toyota	<b>Model</b>	Veloz
<b>YOM</b>	2025	<b>Odo Meter Reading</b>	11,092
<b>Registration No.</b>	CCG6996	<b>Chassis No.</b>	MHFAB1BY8R322595
<b>CC</b>	1.5	<b>Transmission</b>	CVT
<b>Fuel Type</b>	Gas	<b>Type of Body</b>	Wagon
<b>Colour</b>	Black

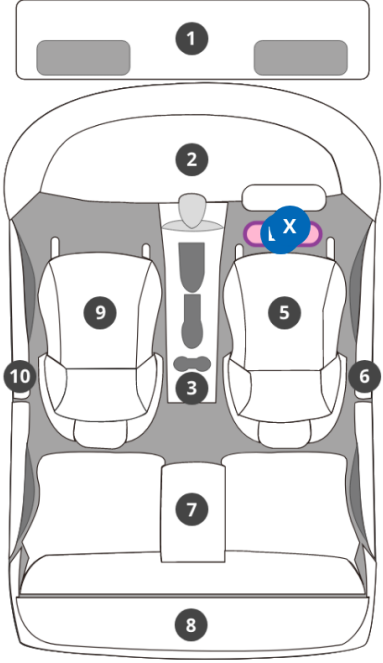
<b>Interior Evaluation :</b> <span style="float: right; color: red; font-weight: bold;">B</span>	<b>Exterior Evaluation :</b> <span style="float: right; color: red; font-weight: bold;">D</span>

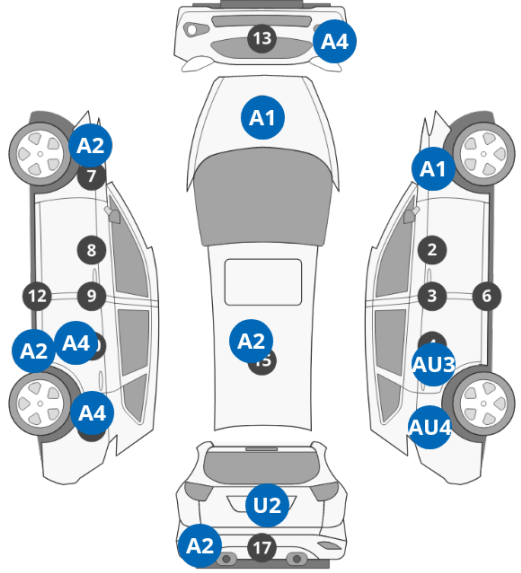
<p><b>A</b> : Scratch <b>AU</b> : Scratch &amp; Dent <b>B</b> : Modified <b>C</b> : Corrosion <b>G</b> : Stone chip <b>P</b> : Faded <b>S</b> : Rust <b>SC</b> : Rust &amp; Corrosion <b>U</b> : Dent <b>X</b> : Defective <b>Y</b> : Crack, Gap</p>
<b>Remarks</b> (L) Front Floor Mat - Worked - Small / Mat Other - Missing - Yes	<b>Remarks</b> (L) Rear Fender, Molding - Scratch - Large / (L) Rear Door, Molding - Scratch - Large / (L) Step, In-panel, Side Spoiler - Scratch - Small / (R) Rear Fender, Molding - Scratch & Dent - Large / (R) Rear Door, Molding - Scratch & Dent - Medium / Front Bumper, Grille, Lamps - Scratch - Large / (L) Front Fender, Molding - Scratch - Small / (R) Front Fender, Molding - Scratch - Minimal / Bonnet, Headlight - Scratch - Minimal / Roof - Scratch - Small

<b>Inspector Notes</b>
With LTO plate and Spare tire and Jack and Incomplete Tools, No warranty booklet and scratch headlight and tail light, Crack tail light.
