General Information

Make	Toyota	Model	Innova
YOM	2023	Odo Meter Reading	53,659
Registration No.	NHC8235	Chassis No.	PA2JA8EM6N0118668
CC	2.8	Transmission	A/T
Fuel Type	Diesel	Type of Body	Wagon
Colour	Red Mica Metallic

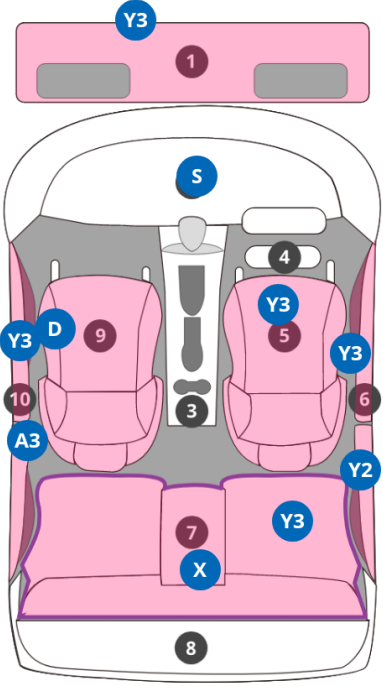
Interior Evaluation : C	Exterior Evaluation : E

<p>a : Cut, Fray d : Loose, Deformed k : Animal Hair s : Smell t : Cigarette Burns x : Defective y : Stain</p>

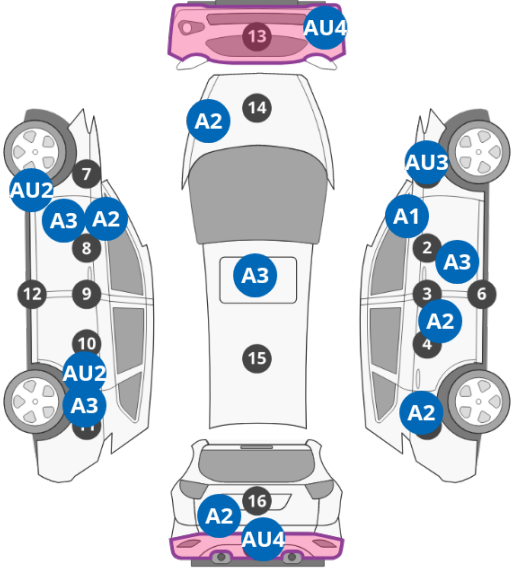
<p>A : Scratch AU : Scratch & Dent B : Modified C : Corrosion G : Stone chip P : Faded S : Rust SC : Rust & Corrosion U : Dent X : Defective Y : Crack, Gap</p>
<p>Remarks Overall Interior - Smell - Yes / (R) Front Seat - Grime - Medium / (L) Front Seat - Worn - Yes / (L) Front Trim - Grime - Medium / (L) Rear Trim - Cut, Crack - Medium / (R) Front Trim - Grime - Medium / (R) Rear Trim - Grime - Small / Rear Seat Head Rest - Missing - Yes / Ceiling - Grime - Medium / Rear Seat - Grime - Medium</p>	<p>Remarks (L) Front Door - Repair Traces - Yes / (L) Rear Door - Repair Traces - Yes / (R) Front Fender, Molding - Scratch & Dent - Medium / (R) Mirror - Scratch - Minimal / (R) Front Door, Molding - Scratch - Medium / (R) Rear Door, Molding - Scratch - Small / (R) Rear Fender, Molding - Scratch - Small / Rear Bumper, Lamps, Panels - Scratch & Dent - Large / Trunk Hood, Rear Gate - Scratch - Small / Rear Bumper, Lamps, Panels - Repair mark - Yes / Front Bumper, Grille, Lamps - Repair mark - Yes / (L) Rear Fender, Molding - Scratch - Medium / (L) Rear Door, Molding - Scratch & Dent - Small / (L) Front Door, Molding - Scratch - Medium / (L) Front Fender, Molding - Scratch & Dent - Small / (L) Mirror - Scratch - Small / Front Bumper, Grille, Lamps - Scratch & Dent - Large / Bonnet, Headlight - Scratch - Small / Roof - Scratch - Medium</p>
