## General Information

| Make | Toyota | Model | Veloz |

## Body / Panel Condition

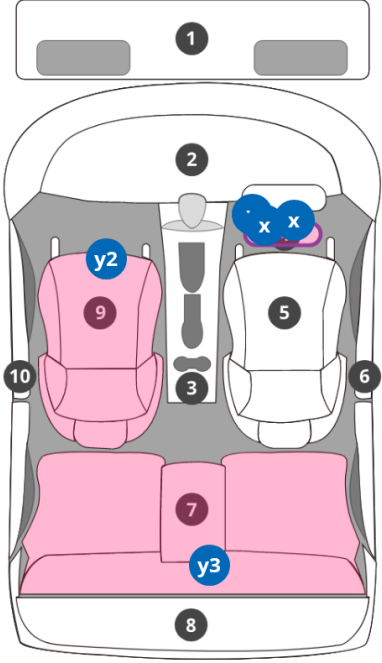
| Interior Evaluation : <b>B</b> | Exterior Evaluation : <b>E</b> |
|---|---|
| <p><b>Remarks</b><br/>(R) Front Floor Mat - Missing - Yes / (L) Front Floor Mat - Missing - Yes / Mat Other - Missing - Yes / Rear Seat - Grime - Medium / (L) Front Seat - Grime - Small</p> | <p><b>Remarks</b><br/>Rear Bumper, Lamps, Panels - Scratch &amp; Dent - Large / (R) Rear Fender, Molding - Partially Missing - Yes / (R) Step, In-panel, Side Spoiler - Crack, Gap - Large / (R) Front Fender, Molding - Partially Missing - Yes / (R) Rear Door, Molding - Scratch &amp; Dent - Small / (R) Front Fender, Molding - Scratch &amp; Dent - Small / Front Bumper, Grille, Lamps - Scratch &amp; Dent - Medium / (L) Front Fender, Molding - Partially Missing - Yes / (L) Rear Fender, Molding - Partially Missing - Yes / (L) Rear Door, Molding - Dent - Small / Trunk Hood, Rear Gate - Scratch &amp; Dent - Small</p> |
