## General Information

| Make | Toyota | Model | Vios |
| Registration No. | NGX5900 | Chassis No. | PA1B18F30N4171809 |

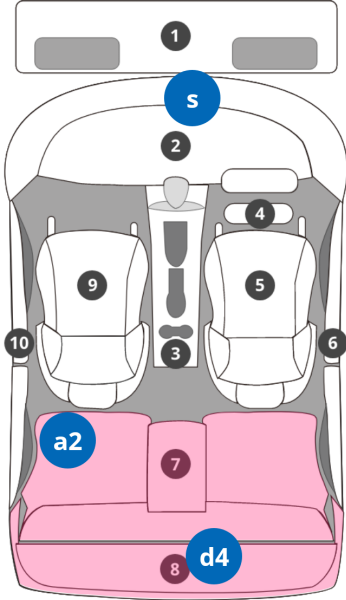
| Interior Evaluation : <b>C</b> | Exterior Evaluation : <b>D</b> |
|---|---|
| <b>Remarks</b><br>Trunk Room - Loose, Deformed - Large / Rear Seat - Cut, Crack - Small / Overall Interior - Smell - Yes / Overall Interior - Worn as per age - Yes | <b>Remarks</b><br>(R) Front Door - Repair Traces - Yes / (R) Step - Repair Traces - Yes / (R) Front Fender - Repair Traces - Yes / Bonnet - Repair Traces - Yes / (L) Front Fender - Repair Traces - Yes / (L) Front Door - Repair Traces - Yes / (L) Step - Repair Traces - Yes / (L) Rear Fender - Repair Traces - Yes / Trunk Hood, Rear Gate - Repair Traces - Yes / (R) Rear Fender - Repair Traces - Yes / (R) Rear Door - Repair Traces - Yes / Roof - Repair Traces - Yes / Rear Bumper, Lamps, Panels - Crack, Gap - Medium / Trunk Hood, Rear Gate - Scratch & Dent - Small / Front Bumper, Grille, Lamps - Repair mark - Yes / Member (Bolted) - Dent - Yes / Front Bumper, Grille, Lamps - Scratch & Dent - Medium / (L) Front Wheel, Cover - Cap Missing - Yes / (L) Mirror - Crack - Damaged / (L) Rear Fender, Molding - Repair mark - Yes / (L) Front Fender, Molding - Repair mark - Difference in Color / (R) Front Fender, Molding - Repair mark - Difference in Color / (R) Rear Fender, Molding - Repair mark - Difference in Color / Trunk Hood, Rear Gate - Repair mark - Difference in Color |
