## General Information

<b>Make</b>	Toyota	<b>Model</b>	Avanza
<b>YOM</b>	2025	<b>Odo Meter Reading</b>	16,945
<b>Registration No.</b>	NJF3329	<b>Chassis No.</b>	MHFAA1BY8R0034800
<b>CC</b>	1.3	<b>Transmission</b>	CVT
<b>Fuel Type</b>	Gas	<b>Type of Body</b>	MPV
<b>Colour</b>	Green

## Body / Panel Condition

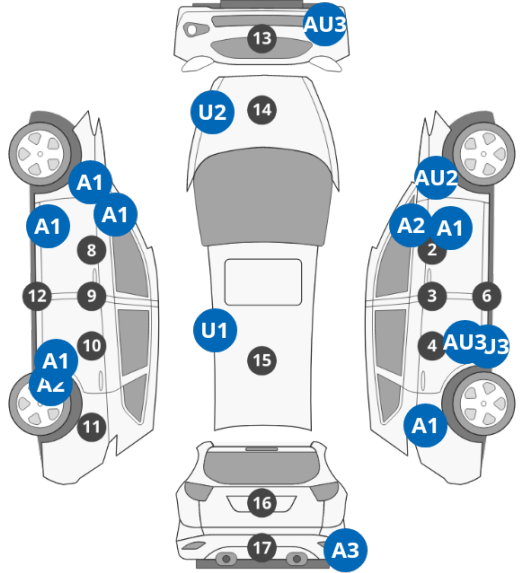
<p><b>A</b> : Scratch <b>AU</b> : Scratch &amp; Dent <b>B</b> : Modified <b>C</b> : Corrosion <b>G</b> : Stone chip <b>P</b> : Faded <b>S</b> : Rust <b>SC</b> : Rust &amp; Corrosion <b>U</b> : Dent <b>X</b> : Defective <b>Y</b> : Crack, Gap</p>
<p><b>Remarks</b> (L) Front Floor Mat - Worked - Small / Ceiling - Crinkle - Medium / Dashboard - Traces of Adhesive Tape - Yes</p>	<p><b>Remarks</b> (R) Front Fender, Molding - Scratch &amp; Dent - Small / (R) Mirror - Scratch - Small / (R) Step, In-panel, Side Spoiler - Scratch &amp; Dent - Medium / (R) Rear Door, Molding - Scratch &amp; Dent - Medium / (R) Front Door, Molding - Scratch - Minimal / (R) Rear Fender, Molding - Scratch - Minimal / Rear Bumper, Lamps, Panels - Scratch - Medium / (L) Rear Fender, Molding - Scratch - Small / (L) Rear Door, Molding - Scratch - Minimal / (L) Front Door, Molding - Scratch - Minimal / (L) Mirror - Scratch - Minimal / (L) Front Fender, Molding - Scratch - Minimal / Bonnet, Headlight - Dent - Small / Front Bumper, Grille, Lamps - Scratch &amp; Dent - Medium / Roof - Dent - Minimal</p>
