## General Information

Date & Time: 03, Oct, 2025 08:40

<b>Make</b>	Toyota	<b>Model</b>	Vios
<b>YOM</b>	2025	<b>Odo Meter Reading</b>	29,479
<b>Registration No.</b>	NKE9925	<b>Chassis No.</b>	PA1B18F33R4265382
<b>CC</b>	1.3	<b>Transmission</b>	CVT
<b>Fuel Type</b>	Gas	<b>Type of Body</b>	Sedan
<b>Colour</b>	Blue

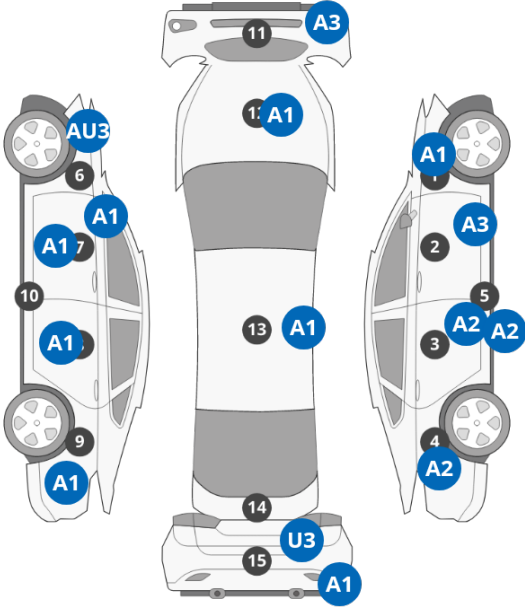
<p><b>A</b> : Scratch <b>AU</b> : Scratch &amp; Dent <b>B</b> : Modified <b>C</b> : Corrosion <b>G</b> : Stone chip <b>P</b> : Faded <b>S</b> : Rust <b>SC</b> : Rust &amp; Corrosion <b>U</b> : Dent <b>X</b> : Defective <b>Y</b> : Crack, Gap</p>
<p><b>Remarks</b> (L) Front Floor Mat - Cut, Crack - Medium / (L) Front Trim - Grime - Small / Ceiling - Grime - Minimal / (R) Front Trim - Grime - Minimal / (R) Front Seat - Grime - Medium / Rear Seat - Grime - Small</p>	<p><b>Remarks</b> (L) Rear Fender, Molding - Scratch - Minimal / Rear Bumper, Lamps, Panels - Scratch - Minimal / Trunk Hood, Rear Gate - Dent - Medium / (R) Rear Fender, Molding - Scratch - Small / (R) Rear Door, Molding - Scratch - Small / (R) Front Door, Molding - Scratch - Medium / (R) Step, In-panel, Side Spoiler - Scratch - Small / Front Bumper, Grille, Lamps - Scratch - Medium / (L) Front Fender, Molding - Scratch &amp; Dent - Medium / (L) Mirror - Scratch - Minimal / (L) Front Door, Molding - Scratch - Minimal / (L) Rear Door, Molding - Scratch - Minimal / Roof - Scratch - Minimal / Bonnet, Headlight - Scratch - Minimal / (R) Front Fender, Molding - Scratch - Minimal</p>
