General Information

Make	Toyota	Model	Hilux
YOM	2019	Odo Meter Reading	115,101
Registration No.	NBE4002	Chassis No.	MR0GB8DD1J1419332
CC	2.4	Transmission	A/T
Fuel Type	Diesel	Type of Body	Pickup
Colour	White

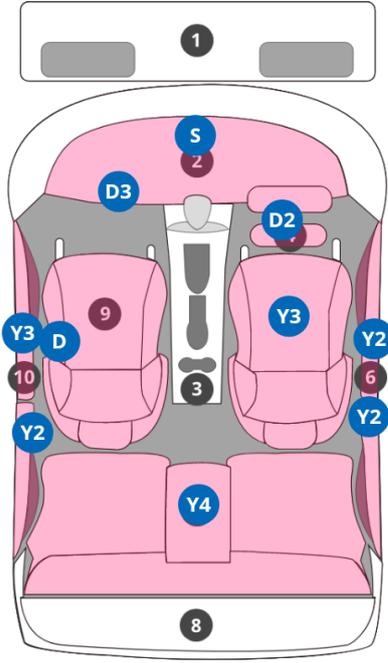
Interior Evaluation : C	Exterior Evaluation : E

<p>a : Cut, Fray d : Loose, Deformed k : Animal Hair s : Smell t : Cigarette Burns x : Defective y : Stain</p>

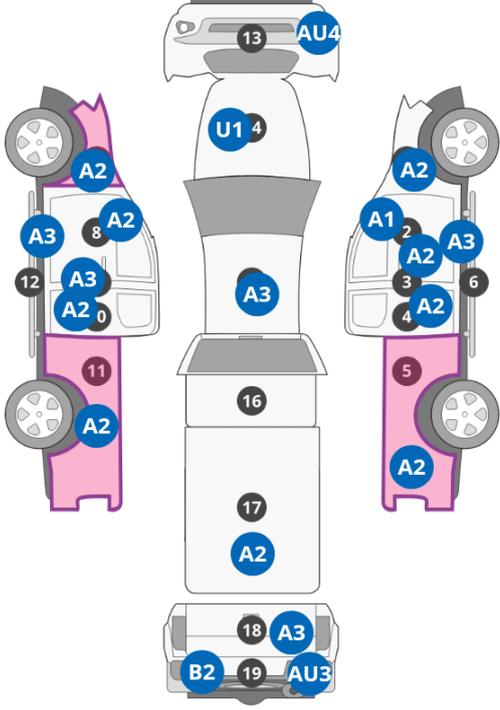
<p>A : Scratch AU : Scratch & Dent B : Modified C : Corrosion G : Stone chip P : Faded S : Rust SC : Rust & Corrosion U : Dent X : Defective Y : Crack, Gap</p>
<p>Remarks Rear Seat - Grime - Large / (R) Rear Trim - Grime - Small / (R) Front Trim - Grime - Small / (R) Front Seat - Grime - Medium / (L) Rear Trim - Grime - Small / (L) Front Trim - Grime - Medium / (L) Front Seat - Worn - Yes / (L) Front Floor Mat - Worked - Small / Overall Interior - Smell - Yes / Overall Interior - Worn as per age - Yes / Instrument Panel - Loose, Deformed - Medium</p>	<p>Remarks (R) Front Fender - Repair Traces - Yes / Bonnet - Repair Traces - Yes / (L) Rear Door - Repair Traces - Yes / (L) Rear Corner Panel - Repair Traces - Yes / Roof - Repair Traces - Yes / Overall Exterior - Worn as per age - Yes / (R) Front Fender, Molding - Scratch - Small / (R) Mirror - Scratch - Minimal / (R) Step, In-panel, Side Spoiler - Scratch - Medium / (R) Front Door, Molding - Scratch - Small / (R) Rear Door, Molding - Scratch - Small / (R) Side Gate - Repair mark - Yes / (R) Side Gate - Scratch - Small / Rear Bumper, Lamps, Panels - Modified - Small / Rear Bumper, Lamps, Panels - Scratch & Dent - Medium / Rear Gate - Scratch - Medium / Cargo Bed Floor - Scratch - Small / (L) Side Gate - Repair mark - Yes / (L) Side Gate - Scratch - Small / (L) Step, In-panel, Side Spoiler - Scratch - Medium / (L) Rear Door, Molding - Scratch - Small / (L) Front Door, Molding - Scratch - Medium / (L) Mirror - Scratch - Small / (L) Front Fender, Molding - Repair mark - Yes / (L) Front Fender, Molding - Scratch - Small / Front Bumper, Grille, Lamps - Scratch & Dent - Large / Bonnet, Headlight - Dent - Minimal / Roof - Scratch - Medium</p>
