General Information

| Make | Toyota | Model | Vios |
| Registration No. | DBJ8078 | Chassis No. | PA1B18F36P4227271 |

Body / Panel Condition

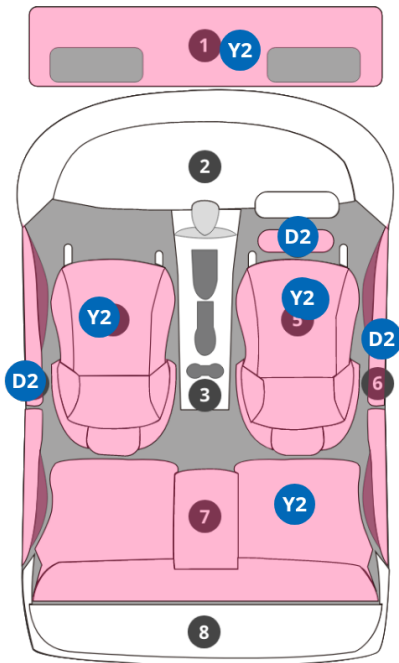
| <p>Remarks Rear Seat - Grime - Small / (R) Front Seat - Cigarette Burns - Burnt Minimal / (R) Front Seat - Grime - Small / (L) Front Seat - Grime - Small / (L) Front Floor Mat - Worked - Small / (L) Front Trim - Worked - Small / (R) Front Trim - Worked - Small / Ceiling - Grime - Small</p> | <p>Remarks (L) Rear Door, Molding - Scratch & Dent - Small / (L) Front Door, Molding - Scratch - Medium / (L) Front Fender, Molding - Scratch - Minimal / (L) Mirror - Scratch - Minimal / Front Bumper, Grille, Lamps - Scratch - Small / Member (Bolted) - Dent - Yes / Bonnet, Headlight - Scratch - Small / (R) Front Door, Molding - Dent - Minimal / (R) Rear Door, Molding - Scratch & Dent - Minimal / (R) Rear Fender, Molding - Scratch - Minimal / Trunk Hood, Rear Gate - Scratch - Minimal / Rear Bumper, Lamps, Panels - Scratch - Minimal / (L) Rear Fender, Molding - Scratch - Small / Roof - Scratch - Minimal</p> |
