General Information

| Make | Toyota | Model | Wigo |
| YOM | 2024 | Odo Meter Reading | 12,656 |

Body / Panel Condition

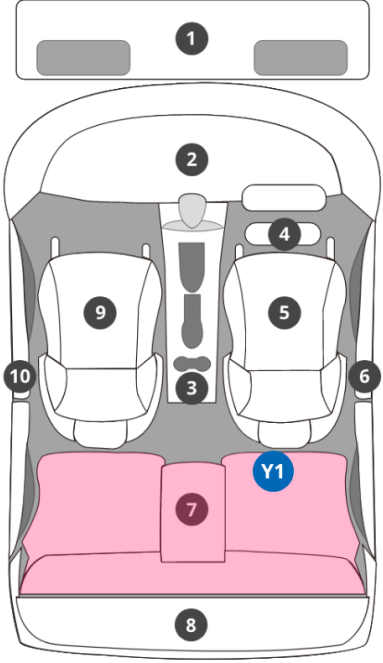
| Interior Evaluation : | A | Exterior Evaluation : | A |

| <p>Remarks Rear Seat - Grime - Minimal</p> | | <p>Remarks (L) Rear Fender, Molding - Scratch - Minimal / Rear Bumper, Lamps, Panels - Scratch - Minimal / (L) Rear Door, Molding - Scratch - Minimal / Front Bumper, Grille, Lamps - Scratch - Minimal / (R) Front Door, Molding - Dent - Minimal / (R) Rear Fender, Molding - Scratch - Minimal / Trunk Hood, Rear Gate - Scratch - Minimal / Bonnet, Headlight - Scratch - Minimal</p> | |

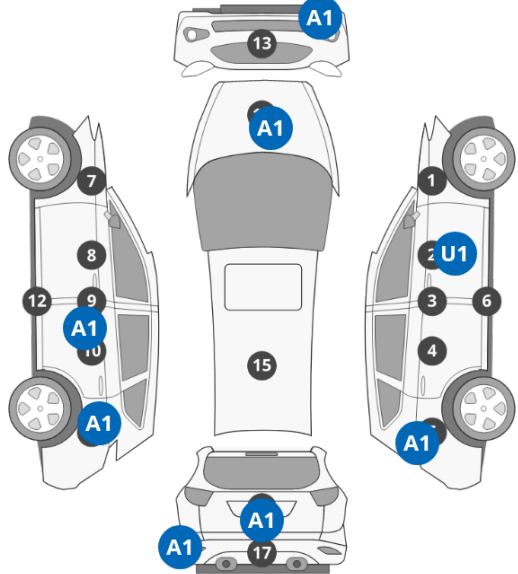
| With LTO plate and Sparetire and Jack and Warranty booklet, No Tools and Scratch headlight and tail light, no trunk cover. |
