## General Information

Date & Time: 06, Oct, 2025 17:28

<b>Make</b>	Toyota	<b>Model</b>	Vios
<b>YOM</b>	2023	<b>Odo Meter Reading</b>	32,668
<b>Registration No.</b>	DAS7913	<b>Chassis No.</b>	PA1B18F31N4195228
<b>CC</b>	1.3	<b>Transmission</b>	CVT
<b>Fuel Type</b>	Gas	<b>Type of Body</b>	Sedan
<b>Colour</b>	Silver

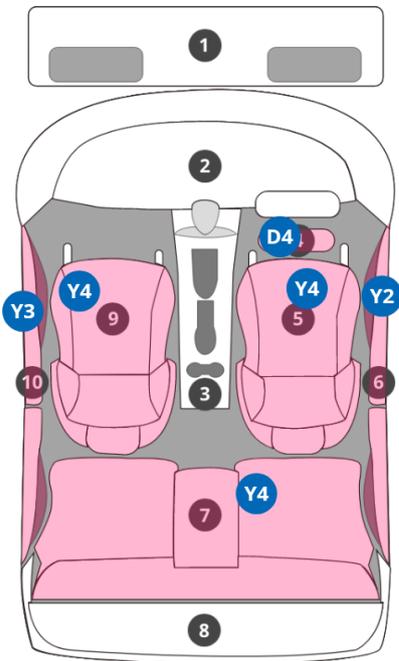
<b>Interior Evaluation :</b> <span style="float: right; color: red; font-weight: bold;">C</span>	<b>Exterior Evaluation :</b> <span style="float: right; color: red; font-weight: bold;">E</span>

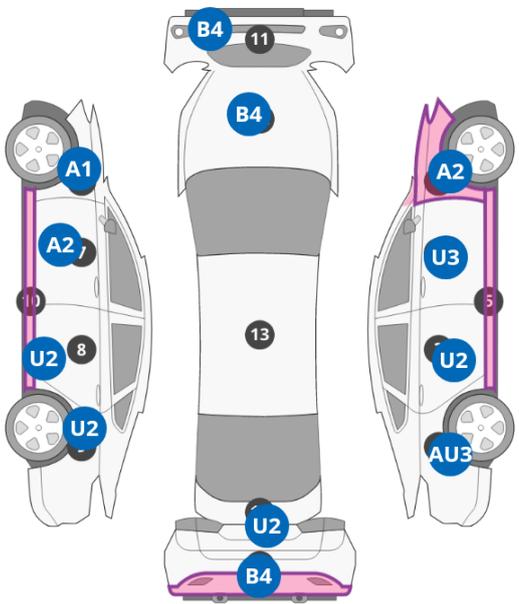
<p><b>A</b> : Scratch <b>AU</b> : Scratch &amp; Dent <b>B</b> : Modified <b>C</b> : Corrosion <b>G</b> : Stone chip <b>P</b> : Faded <b>S</b> : Rust <b>SC</b> : Rust &amp; Corrosion <b>U</b> : Dent <b>X</b> : Defective <b>Y</b> : Crack, Gap</p>
<p><b>Remarks</b> (L) Front Seat - Grime - Large / (R) Front Seat - Grime - Large / (L) Front Trim - Grime - Medium / (R) Front Trim - Grime - Small / Rear Seat - Grime - Large / (L) Front Floor Mat - Worked - Large</p>	<p><b>Remarks</b> (R) Front Fender - Repair Traces - Yes / Bonnet - Repair Traces - Yes / (L) Step, In-panel, Side Spoiler - Repair mark - Yes / (R) Step, In-panel, Side Spoiler - Repair mark - Yes / (L) Rear Door, Molding - Dent - Small / (R) Front Door, Molding - Dent - Medium / (R) Rear Door, Molding - Dent - Small / (R) Rear Fender, Molding - Scratch &amp; Dent - Medium / Trunk Hood, Rear Gate - Dent - Small / Rear Bumper, Lamps, Panels - Repair mark - Yes / Front Bumper, Grille, Lamps - Modified - Large / Rear Bumper, Lamps, Panels - Modified - Large / (L) Rear Fender, Molding - Dent - Small / (L) Front Door, Molding - Scratch - Small / Bonnet, Headlight - Modified - Large / (L) Front Fender, Molding - Scratch - Minimal / (R) Front Fender, Molding - Repair mark - Yes / (R) Front Fender, Molding - Scratch - Small</p>
