## General Information

| Make | Toyota | Model | Vios |
| Registration No. | DBR1167 | Chassis No. | PA1B18F35R4271300 |

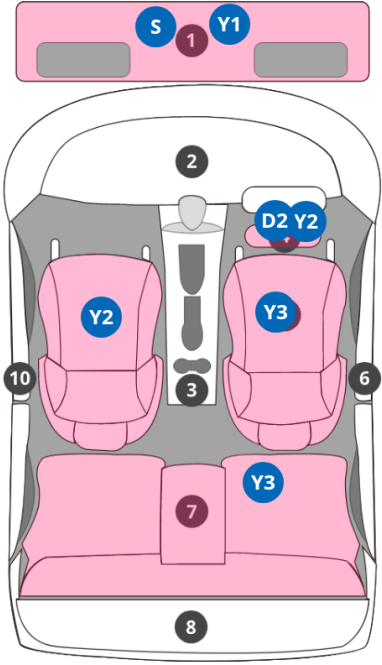
| Interior Evaluation : <b>B</b> | Exterior Evaluation : <b>B</b> |
| <b>Remarks</b><br>Rear Seat - Grime - Medium / (R) Front Seat - Grime - Medium / (R) Front Floor Mat - Grime - Small / (L) Front Seat - Grime - Small / (L) Front Floor Mat - Worked - Small / Overall Interior - Smell - Yes / Ceiling - Grime - Minimal | <b>Remarks</b><br>Bonnet - Repair Traces - Yes / Trunk Hood, Rear Gate - Repair Traces - Yes / Front Bumper, Grille, Lamps - Scratch - Small / Rear Bumper, Lamps, Panels - Scratch - Small / (L) Rear Fender, Molding - Scratch - Minimal / (R) Front Door, Molding - Scratch - Minimal / (L) Mirror - Scratch - Minimal / (R) Mirror - Scratch - Minimal / Bonnet, Headlight - Repair mark - Yes / Trunk Hood, Rear Gate - Repair mark - Yes / Roof - Scratch & Dent - Minimal / Bonnet, Headlight - Scratch - Small / (R) Rear Fender, Molding - Scratch - Minimal / Trunk Hood, Rear Gate - Scratch - Minimal / (L) Rear Door, Molding - Scratch - Minimal |
