## General Information

<b>Make</b>	Toyota	<b>Model</b>	Vios
<b>YOM</b>	2025	<b>Odo Meter Reading</b>	6,055
<b>Registration No.</b>	CCG6640	<b>Chassis No.</b>	PA1B18F31R4274419
<b>CC</b>	1.3	<b>Transmission</b>	CVT
<b>Fuel Type</b>	Gas	<b>Type of Body</b>	Sedan
<b>Colour</b>	Black

## Body / Panel Condition

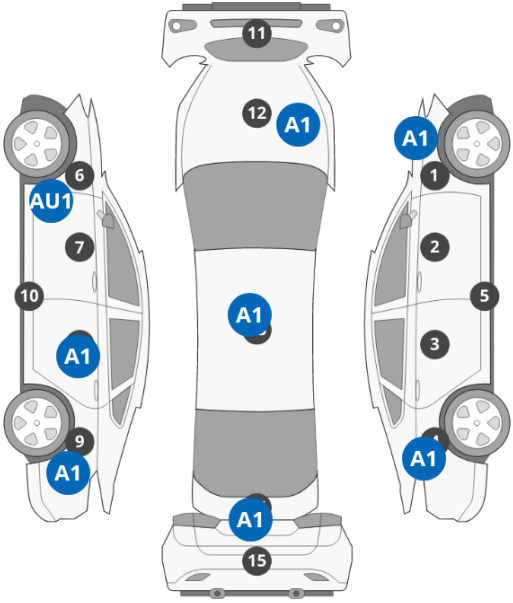
<p><b>A</b> : Scratch <b>AU</b> : Scratch &amp; Dent <b>B</b> : Modified <b>C</b> : Corrosion <b>G</b> : Stone chip <b>P</b> : Faded <b>S</b> : Rust <b>SC</b> : Rust &amp; Corrosion <b>U</b> : Dent <b>X</b> : Defective <b>Y</b> : Crack, Gap</p>
<p><b>Remarks</b> Rear Seat - Grime - Minimal / Mat Other - Grime - Small / (L) Front Floor Mat - Worked - Small</p>	<p><b>Remarks</b> Bonnet, Headlight - Scratch - Minimal / (R) Front Fender, Molding - Scratch - Minimal / (R) Rear Fender, Molding - Scratch - Minimal / Trunk Hood, Rear Gate - Scratch - Minimal / Roof - Scratch - Minimal / (L) Rear Door, Molding - Scratch - Minimal / (L) Rear Fender, Molding - Scratch - Minimal / (L) Front Door, Molding - Scratch &amp; Dent - Minimal</p>
