## General Information

<b>Make</b>	Toyota	<b>Model</b>	Avanza
<b>YOM</b>	2024	<b>Odo Meter Reading</b>	38,462
<b>Registration No.</b>	EAJ4775	<b>Chassis No.</b>	MHFAA1BY4R0025902
<b>CC</b>	1.3	<b>Transmission</b>	CVT
<b>Fuel Type</b>	Gas	<b>Type of Body</b>	MPV
<b>Colour</b>	Red Mica Metallic

## Body / Panel Condition

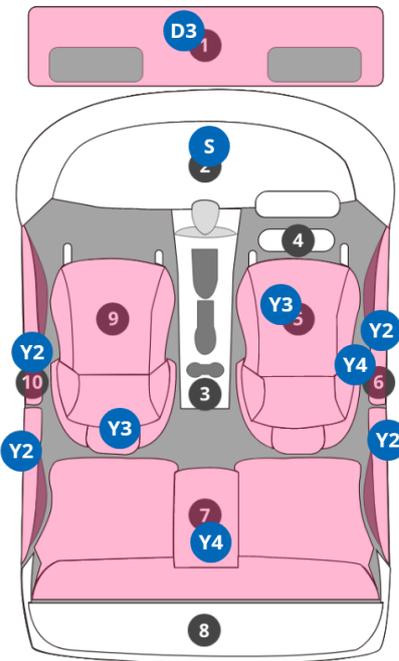
<b>Interior Evaluation :</b> <span style="float: right; color: red; font-weight: bold;">C</span>	<b>Exterior Evaluation :</b> <span style="float: right; color: red; font-weight: bold;">C</span>

<p><b>a</b> : Cut, Fray <b>d</b> : Loose, Deformed <b>k</b> : Animal Hair <b>s</b> : Smell <b>t</b> : Cigarette Burns <b>x</b> : Defective <b>y</b> : Stain</p>

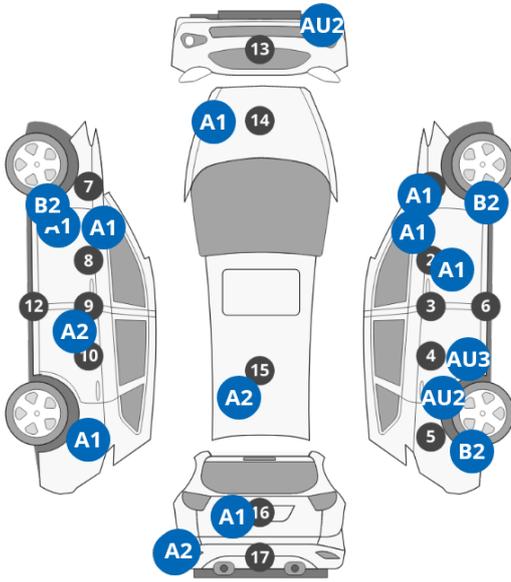
<p><b>A</b> : Scratch <b>AU</b> : Scratch &amp; Dent <b>B</b> : Modified <b>C</b> : Corrosion <b>G</b> : Stone chip <b>P</b> : Faded <b>S</b> : Rust <b>SC</b> : Rust &amp; Corrosion <b>U</b> : Dent <b>X</b> : Defective <b>Y</b> : Crack, Gap</p>
<p><b>Remarks</b> Overall Interior - Smell - Yes / (R) Front Seat belt - Grime - Large / (R) Front Seat - Grime - Medium / Rear Seat - Grime - Large / (R) Rear Trim - Grime - Small / (L) Rear Trim - Grime - Small / (R) Front Trim - Grime - Small / Ceiling - Crinkle - Medium / (L) Front Seat - Grime - Medium</p>	<p><b>Remarks</b> (R) Front Fender, Molding - Modified - Small / (R) Rear Fender, Molding - Modified - Small / (R) Front Fender, Molding - Scratch - Minimal / (R) Mirror - Scratch - Minimal / (R) Front Door, Molding - Scratch - Minimal / (R) Rear Door, Molding - Scratch &amp; Dent - Medium / (R) Rear Fender, Molding - Scratch &amp; Dent - Small / Rear Bumper, Lamps, Panels - Modified - Small / Rear Bumper, Lamps, Panels - Scratch - Small / Trunk Hood, Rear Gate - Scratch - Minimal / (L) Rear Fender, Molding - Scratch - Minimal / (L) Rear Door, Molding - Scratch - Small / (L) Front Door, Molding - Scratch - Minimal / (L) Mirror - Scratch - Minimal / (L) Front Fender, Molding - Modified - Small / Front Bumper, Grille, Lamps - Scratch &amp; Dent - Small / Bonnet, Headlight - Scratch - Minimal / Roof - Scratch - Small</p>
