## General Information

| Make | Toyota | Model | Vios |
| Registration No. | NFA4442 | Chassis No. | PA1B18F32P4207938 |

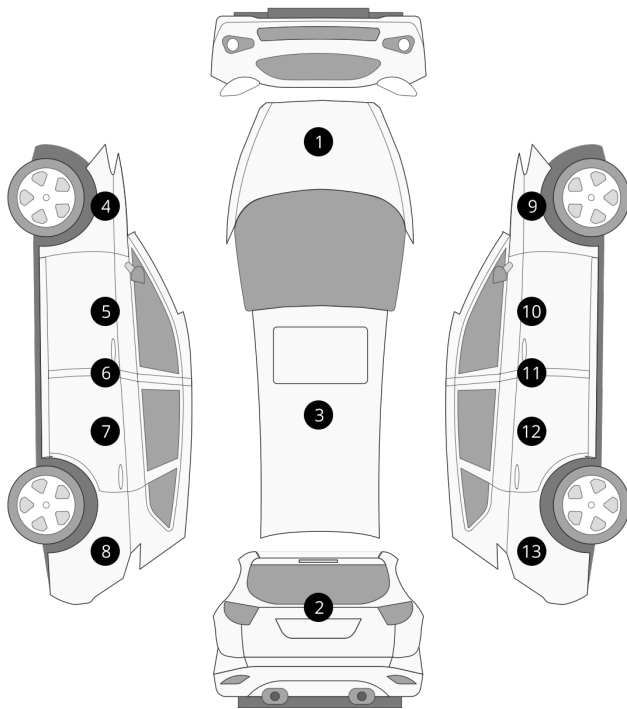
## Body / Panel Condition

| # | Area | Thickness(um) | | | |
|---|---|---|---|---|---|
| 1 | Bonnet | 272.6 | 264 | 255 | 299 |
| 2 | Boot Lid | 245.3 | 273 | 221 | 242 |
| 3 | Roof | 99.4 | 109 | 101 | 94/94 |
| 4 | Left Front Fender | 255.3 | 244 | 257 | 265 |
| 5 | Left Front Door | 147.0 | 158 | 129 | 154 |
| 7 | Left Rear Door | 110.3 | 121 | 107 | 103 |
| 8 | Left Back Panel | 106.3 | 109 | 104 | 106 |
| 9 | Right Front Fender | 232.0 | 308 | 181 | 207 |
| 10 | Right Front Door | 139.3 | 142 | 138 | 138 |
| 12 | Right Rear Door | 101.3 | 100 | 101 | 103 |
| 13 | Right Back Panel | 103.8 | 105 | 99 | 107 |

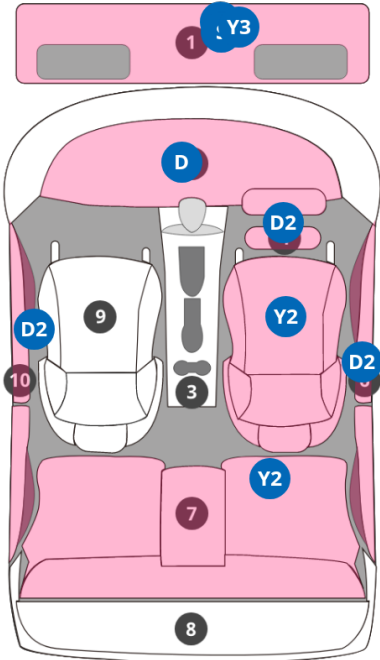
| Interior Evaluation : <span style="color: red;">B</span> | | Exterior Evaluation : <span style="color: red;">D</span> | |
| <p><b>Remarks</b></p> <p>Overall Interior - Animal Hair - Yes / Overall Interior - Smell - Yes / Ceiling - Grime - Medium / Rear Seat - Grime - Small / (R) Front Seat - Grime - Small / (L) Front Floor Mat - Worked - Small / (L) Front Trim - Worked - Small / (R) Front Trim - Worked - Small / Dashboard - Traces of Adhesive Tape - Yes</p> | | <p><b>Remarks</b></p> <p>(R) Step - Repair Traces - Yes / (R) Front Fender - Repair Traces - Yes / Bonnet - Repair Traces - Yes / (L) Front Fender - Repair Traces - Yes / Trunk Hood, Rear Gate - Repair Traces - Yes / (R) Rear Fender - Repair Traces - Yes / (R) Rear Door - Repair Traces - Yes / Roof - Repair Traces - Yes / Roof - Repair mark - Yes / (R) Front Fender, Molding - Repair mark - Yes / (R) Step, In-panel, Side Spoiler - Repair mark - Yes / (L) Front Fender, Molding - Repair mark - Yes / Trunk Hood, Rear Gate - Repair mark - Yes / Bonnet, Headlight - Repair mark - Yes / (R) Rear Door, Molding - Repair mark - Yes / (R) Rear Fender, Molding - Repair mark - Yes / Member (Bolted) - Dent - Yes / Trunk Hood, Rear Gate - Scratch - Small / (L) Front Door, Molding - Scratch &amp; Dent - Small / (L) Rear Door, Molding - Scratch - Small / (L) Mirror - Scratch - Minimal / (L) Step, In-panel, Side Spoiler - Scratch &amp; Dent - Small / (L) Front Fender, Molding - Scratch - Minimal / Front Bumper, Grille, Lamps - Scratch - Small / (R) Front Fender, Molding - Scratch - Minimal / Bonnet, Headlight - Scratch &amp; Dent - Small / (R) Front Door, Molding - Scratch - Minimal / (R) Rear Door, Molding - Scratch &amp; Dent - Minimal / (R) Rear Fender, Molding - Scratch - Minimal / (R) Step, In-panel, Side Spoiler - Scratch &amp; Dent - Small / Roof - Scratch &amp; Dent - Minimal / (L) Rear Fender, Molding - Scratch - Minimal</p> | |
