## General Information

| Make | Toyota | Model | Wigo |
| Registration No. | NHJ2229 | Chassis No. | MHKA4DF5FPJ081674 |

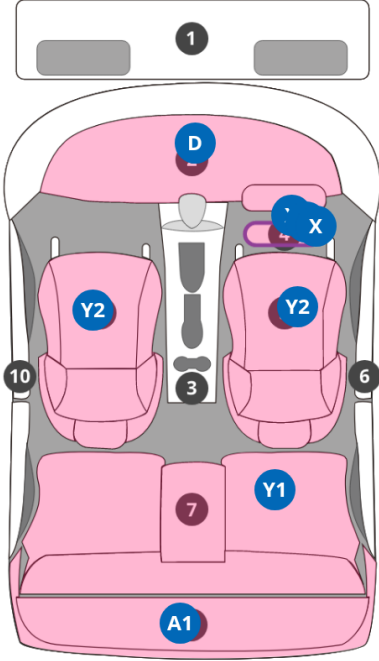
| Interior Evaluation : <b>B</b> | Exterior Evaluation : <b>C</b> |
| <p><b>Remarks</b></p> <p>(R) Front Floor Mat - Missing - Yes / (L) Front Floor Mat - Missing - Yes / Mat Other - Missing - Yes / (R) Front Seat - Grime - Small / Trunk Room - Worn, Scratch, Cut, Crack - Minimal / (L) Front Seat - Grime - Small / Dashboard - Traces of Adhesive Tape - Yes / Rear Seat - Grime - Minimal</p> | <p><b>Remarks</b></p> <p>(R) Front Fender - Repair Traces - Yes / (L) Front Fender - Repair Traces - Yes / (L) Front Fender, Molding - Dent - Small / (L) Front Fender, Molding - Repair mark - Yes / (R) Front Fender, Molding - Repair mark - Yes / (L) Mirror - Scratch - Minimal / (L) Front Door, Molding - Scratch - Small / (L) Rear Door, Molding - Scratch - Small / (L) Step, In-panel, Side Spoiler - Scratch - Small / (L) Rear Fender, Molding - Dent - Minimal / (R) Rear Fender, Molding - Scratch - Minimal / Trunk Hood, Rear Gate - Scratch - Minimal / Rear Bumper, Lamps, Panels - Scratch - Medium / (R) Rear Door, Molding - Scratch - Minimal / (R) Front Door, Molding - Scratch - Minimal / Front Bumper, Grille, Lamps - Scratch - Medium / Bonnet, Headlight - Scratch - Minimal / Roof - Scratch - Small</p> |
