General Information

Date & Time: 06, Oct, 2025 15:46

Make	Toyota	Model	Avanza
YOM	2023	Odo Meter Reading	33,307
Registration No.	NIF7695	Chassis No.	MHFAA1BY5N0008004
CC	1.3	Transmission	M/T
Fuel Type	Gas	Type of Body	MPV
Colour	Silver

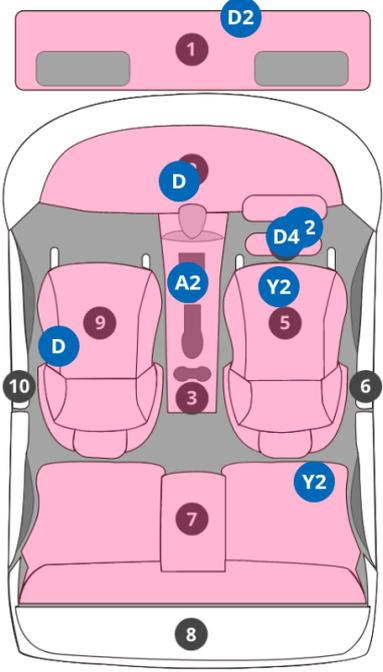
Interior Evaluation : C	Exterior Evaluation : D

<p>A : Scratch AU : Scratch & Dent B : Modified C : Corrosion G : Stone chip P : Faded S : Rust SC : Rust & Corrosion U : Dent X : Defective Y : Crack, Gap</p>
<p>Remarks (L) Front Seat - Worn - Yes / (R) Front Seat - Grime - Small / Rear Seat - Grime - Small / Ceiling - Crinkle - Small / (L) Front Floor Mat - Cut, Crack - Small / (L) Front Floor Mat - Worked - Large / Dashboard - Traces of Adhesive Tape - Yes / Knobs - Worn, Peel, Crack - Small</p>	<p>Remarks Trunk Hood, Rear Gate - Repair Traces - Yes / (R) Front Fender, Molding - Scratch - Minimal / (R) Mirror - Scratch - Minimal / (R) Front Door, Molding - Scratch & Dent - Small / (R) Step, In-panel, Side Spoiler - Scratch - Minimal / (R) Rear Door, Molding - Scratch - Minimal / (R) Rear Fender, Molding - Scratch & Dent - Small / Rear Bumper, Lamps, Panels - Scratch - Small / Trunk Hood, Rear Gate - Dent - Small / (L) Rear Fender, Molding - Scratch & Dent - Medium / (L) Rear Door, Molding - Scratch & Dent - Medium / (L) Mirror - Scratch - Small / (L) Front Door, Molding - Scratch - Minimal / (L) Front Fender, Molding - Dent - Small / Front Bumper, Grille, Lamps - Scratch - Small / Bonnet, Headlight - Dent - Medium / Roof - Scratch - Small</p>
