General Information

Date & Time: 06, Oct, 2025 18:20

Make	Toyota	Model	Vios
YOM	2024	Odo Meter Reading	20,024
Registration No.	NKB7625	Chassis No.	PA1B18F34R4242127
CC	1.3	Transmission	CVT
Fuel Type	Gas	Type of Body	Sedan
Colour	Silver

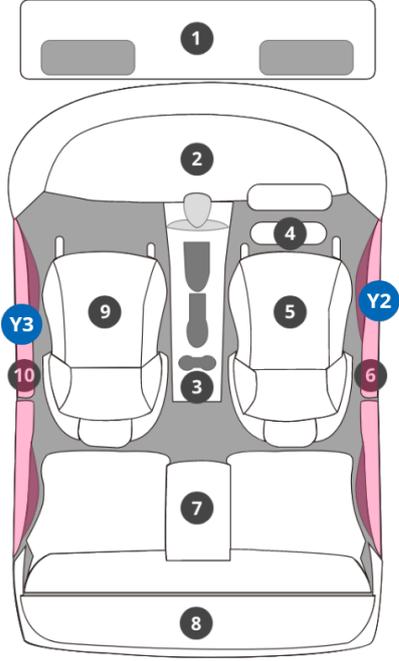
Interior Evaluation : B	Exterior Evaluation : D

<p>a : Cut, Fray d : Loose, Deformed k : Animal Hair s : Smell t : Cigarette Burns x : Defective y : Stain</p>

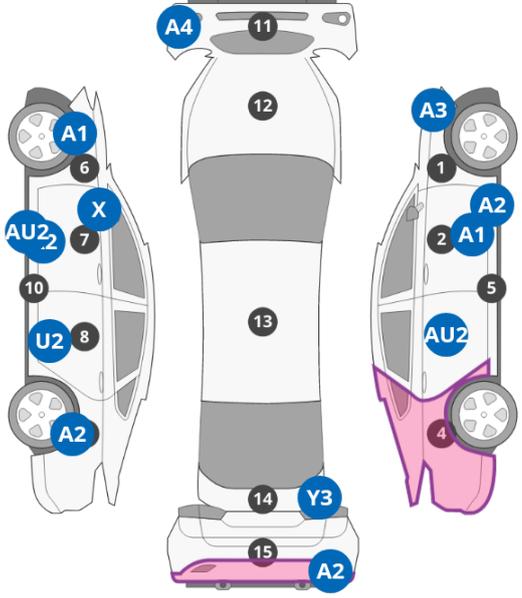
<p>A : Scratch AU : Scratch & Dent B : Modified C : Corrosion G : Stone chip P : Faded S : Rust SC : Rust & Corrosion U : Dent X : Defective Y : Crack, Gap</p>
<p>Remarks (L) Front Trim - Grime - Medium / (R) Front Trim - Grime - Small</p>	<p>Remarks (R) Step - Repair Traces - Yes / (L) Step - Repair Traces - Yes / (L) Rear Fender - Repair Traces - Yes / Trunk Hood, Rear Gate - Repair Traces - Yes / Rear End Panel - Repair Traces - Yes / (R) Rear Fender - Repair Traces - Yes / (R) Rear Fender - Replaced - Yes / Front Bumper, Grille, Lamps - Scratch - Large / (L) Rear Door, Molding - Dent - Small / (L) Front Fender, Molding - Scratch - Minimal / (L) Front Door, Molding - Scratch - Small / (L) Step, In-panel, Side Spoiler - Scratch & Dent - Small / (L) Mirror - Stuck - Yes / (L) Rear Fender, Molding - Scratch - Small / Rear Bumper, Lamps, Panels - Repair mark - Yes / Rear Bumper, Lamps, Panels - Scratch - Small / Trunk Hood, Rear Gate - Crack, Gap - Medium / (R) Rear Door, Molding - Scratch & Dent - Small / (R) Front Door, Molding - Scratch - Minimal / (R) Step, In-panel, Side Spoiler - Scratch - Small / (R) Front Fender, Molding - Scratch - Medium</p>
