General Information

Make	Toyota	Model	Vios
YOM	2025	Odo Meter Reading	4,951
Registration No.	DBS4484	Chassis No.	PA1B18F33R4281338
CC	1.3	Transmission	CVT
Fuel Type	Gas	Type of Body	Sedan
Colour	Silver

Body / Panel Condition

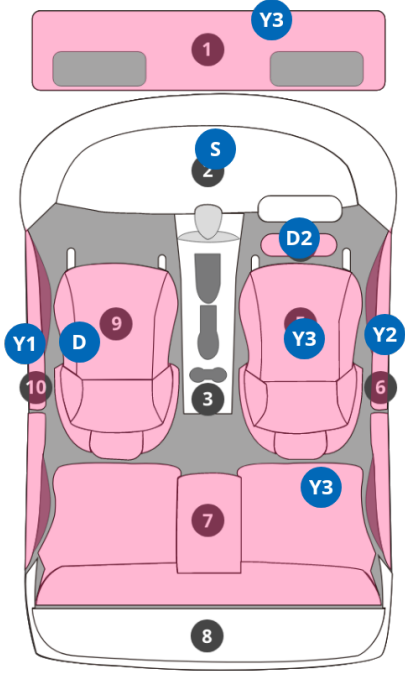
Interior Evaluation : C	Exterior Evaluation : B

<p>a : Cut, Fray d : Loose, Deformed k : Animal Hair s : Smell t : Cigarette Burns x : Defective y : Stain</p>

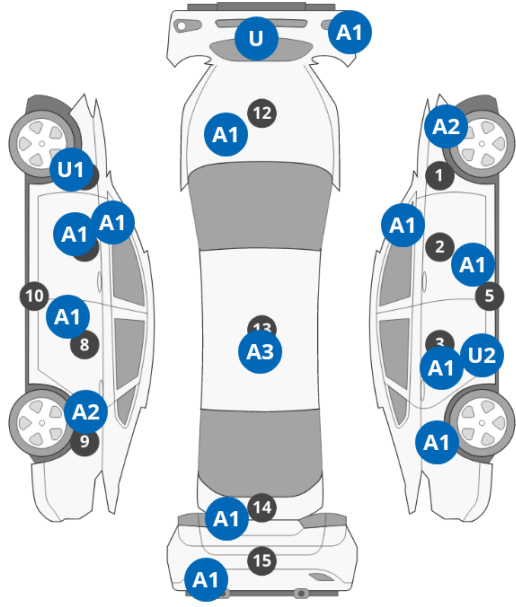
<p>A : Scratch AU : Scratch & Dent B : Modified C : Corrosion G : Stone chip P : Faded S : Rust SC : Rust & Corrosion U : Dent X : Defective Y : Crack, Gap</p>
<p>Remarks Overall Interior - Smell - Yes / (R) Front Seat - Grime - Medium / (L) Front Seat - Worn - Yes / Ceiling - Grime - Medium / Rear Seat - Grime - Medium / (L) Front Floor Mat - Worked - Small / (R) Front Trim - Grime - Small / (L) Front Trim - Grime - Minimal</p>	<p>Remarks Bonnet - Repair Traces - Yes / (L) Front Fender - Repair Traces - Yes / (L) Rear Door - Repair Traces - Yes / Trunk Hood, Rear Gate - Repair Traces - Yes / (R) Front Fender, Molding - Scratch - Small / (R) Mirror - Scratch - Minimal / (R) Step, In-panel, Side Spoiler - Dent - Small / (R) Front Door, Molding - Scratch - Minimal / (R) Rear Door, Molding - Scratch - Minimal / (R) Rear Fender, Molding - Scratch - Minimal / Rear Bumper, Lamps, Panels - Scratch - Minimal / Trunk Hood, Rear Gate - Scratch - Minimal / (L) Rear Fender, Molding - Scratch - Small / (L) Rear Door, Molding - Scratch - Minimal / (L) Front Door, Molding - Scratch - Minimal / (L) Mirror - Scratch - Minimal / Member (Bolted) - Dent - Yes / (L) Front Fender, Molding - Dent - Minimal / Front Bumper, Grille, Lamps - Scratch - Minimal / Bonnet, Headlight - Scratch - Minimal / Roof - Scratch - Medium</p>
