General Information

| Make | Toyota | Model | Vios |
| Registration No. | NKN9427 | Chassis No. | PA1B18F37S4285592 |

Body / Panel Condition

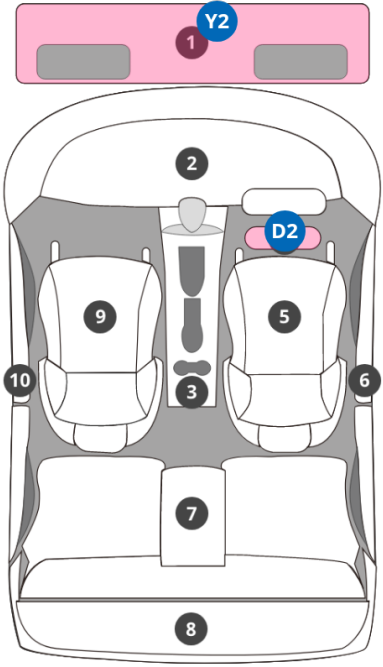
| Interior Evaluation : A | Exterior Evaluation : C |

| Remarks Ceiling - Grime - Small / (L) Front Floor Mat - Worked - Small | Remarks (R) Front Door - Repair Traces - Yes / (R) Step - Repair Traces - Yes / (R) Step - Replaced - Yes / (R) Front Fender - Repair Traces - Yes / Bonnet - Repair Traces - Yes / (L) Front Fender - Repair Traces - Yes / (L) Front Door - Repair Traces - Yes / (L) Step - Repair Traces - Yes / (L) Rear Fender - Repair Traces - Yes / (R) Rear Door - Repair Traces - Yes / (L) Rear Fender, Molding - Scratch & Dent - Medium / (L) Rear Door, Molding - Scratch & Dent - Medium / (L) Rear Fender, Molding - Repair mark - Yes / (L) Rear Door, Molding - Repair mark - Yes / (L) Front Door, Molding - Repair mark - Yes / (R) Front Door, Molding - Repair mark - Yes / (R) Rear Door, Molding - Repair mark - Yes / (R) Rear Fender, Molding - Repair mark - Yes / Bonnet, Headlight - Repair mark - Yes |
