## General Information

<b>Make</b>	Toyota	<b>Model</b>	Vios
<b>YOM</b>	2025	<b>Odo Meter Reading</b>	25,010
<b>Registration No.</b>	NJF2009	<b>Chassis No.</b>	PA1B18F38R4277124
<b>CC</b>	1.3	<b>Transmission</b>	CVT
<b>Fuel Type</b>	Gas	<b>Type of Body</b>	Sedan
<b>Colour</b>	Silver

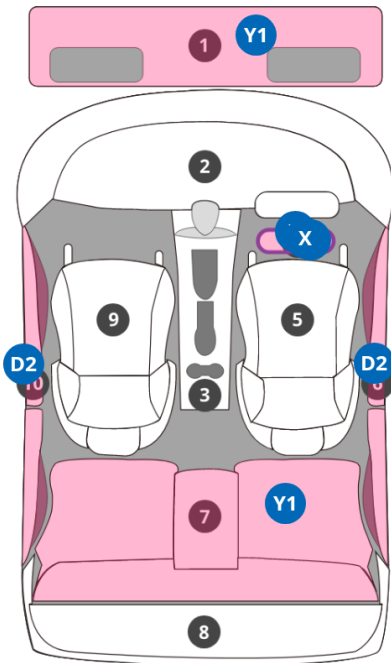
<p><b>A</b> : Scratch <b>AU</b> : Scratch &amp; Dent <b>B</b> : Modified <b>C</b> : Corrosion <b>G</b> : Stone chip <b>P</b> : Faded <b>S</b> : Rust <b>SC</b> : Rust &amp; Corrosion <b>U</b> : Dent <b>X</b> : Defective <b>Y</b> : Crack, Gap</p>
<p><b>Remarks</b> Mat Other - Missing - Yes / (L) Front Floor Mat - Missing - Yes / (R) Front Floor Mat - Missing - Yes / (L) Front Trim - Worked - Small / (R) Front Trim - Worked - Small / Ceiling - Grime - Minimal / Rear Seat - Grime - Minimal</p>	<p><b>Remarks</b> (L) Rear Door, Molding - Dent - Minimal / Trunk Hood, Rear Gate - Scratch - Minimal / Front Bumper, Grille, Lamps - Scratch - Small / (R) Rear Door, Molding - Scratch - Minimal / (R) Mirror - Scratch - Minimal / (L) Mirror - Scratch - Minimal</p>
