## General Information

Date & Time: 04, Oct, 2025 18:09

<b>Make</b>	Toyota	<b>Model</b>	Vios
<b>YOM</b>	2024	<b>Odo Meter Reading</b>	16,686
<b>Registration No.</b>	NHQ4893	<b>Chassis No.</b>	PA1B18F32R232823
<b>CC</b>	1.3	<b>Transmission</b>	CVT
<b>Fuel Type</b>	Gas	<b>Type of Body</b>	Sedan
<b>Colour</b>	Silver

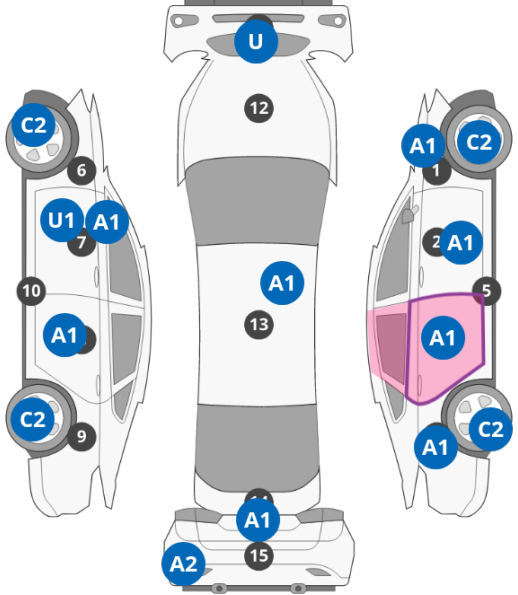
<p><b>A</b> : Scratch <b>AU</b> : Scratch &amp; Dent <b>B</b> : Modified <b>C</b> : Corrosion <b>G</b> : Stone chip <b>P</b> : Faded <b>S</b> : Rust <b>SC</b> : Rust &amp; Corrosion <b>U</b> : Dent <b>X</b> : Defective <b>Y</b> : Crack, Gap</p>
<p><b>Remarks</b> (L) Front Floor Mat - Worked - Small / (L) Front Trim - Worked - Small / (L) Front Seat - Grime - Small / Rear Seat - Grime - Small / Mat Other - Grime - Small / (R) Front Trim - Worked - Small / Ceiling - Grime - Minimal</p>	<p><b>Remarks</b> (L) Rear Wheel, Cover - Scratch, Corrosion - Small / (L) Front Wheel, Cover - Scratch, Corrosion - Small / (R) Rear Wheel, Cover - Scratch, Corrosion - Small / (R) Front Wheel, Cover - Scratch, Corrosion - Small / (L) Rear Door, Molding - Scratch - Minimal / (L) Front Door, Molding - Dent - Minimal / (L) Mirror - Scratch - Minimal / Member (Bolted) - Dent - Yes / (R) Front Fender, Molding - Scratch - Minimal / (R) Rear Door, Molding - Repair mark - Yes / (R) Front Door, Molding - Scratch - Minimal / (R) Rear Door, Molding - Scratch - Minimal / (R) Rear Fender, Molding - Scratch - Minimal / Trunk Hood, Rear Gate - Scratch - Minimal / Roof - Scratch - Minimal / Rear Bumper, Lamps, Panels - Scratch - Small</p>
