## General Information

<b>Make</b>	Toyota	<b>Model</b>	Vios
<b>YOM</b>	2025	<b>Odo Meter Reading</b>	16,355
<b>Registration No.</b>	CCJ3234	<b>Chassis No.</b>	PA1B18F31R4279443
<b>CC</b>	1.3	<b>Transmission</b>	CVT
<b>Fuel Type</b>	Gas	<b>Type of Body</b>	Sedan
<b>Colour</b>	Blackish Red Mica

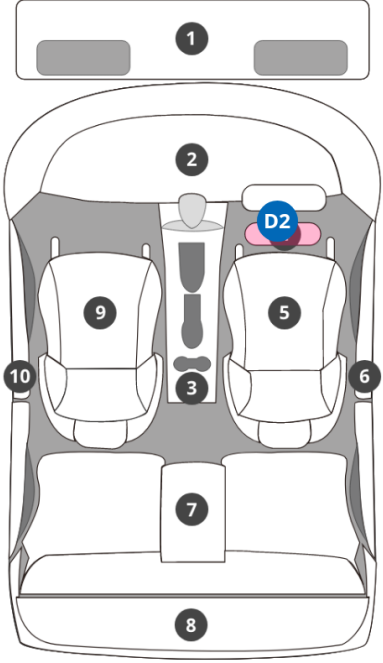
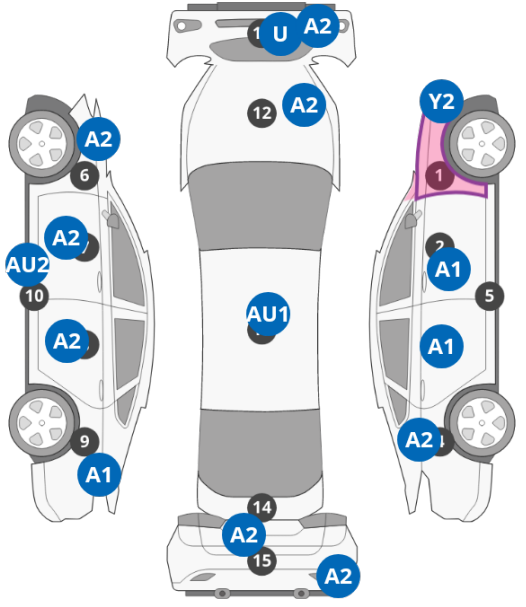
<b>Interior Evaluation :</b>	<b>A</b>	<b>Exterior Evaluation :</b>	<b>B</b>

<p><b>a</b> : Cut, Fray <b>d</b> : Loose, Deformed <b>k</b> : Animal Hair <b>s</b> : Smell <b>t</b> : Cigarette Burns <b>x</b> : Defective <b>y</b> : Stain</p>		<p><b>A</b> : Scratch <b>AU</b> : Scratch &amp; Dent <b>B</b> : Modified <b>C</b> : Corrosion <b>G</b> : Stone chip <b>P</b> : Faded <b>S</b> : Rust <b>SC</b> : Rust &amp; Corrosion <b>U</b> : Dent <b>X</b> : Defective <b>Y</b> : Crack, Gap</p>	
<p><b>Remarks</b> (L) Front Floor Mat - Worked - Small</p>		<p><b>Remarks</b> (R) Front Fender - Repair Traces - Yes / (R) Front Fender, Molding - Repair mark - Yes / Trunk Hood, Rear Gate - Scratch - Small / Rear Bumper, Lamps, Panels - Scratch - Small / (R) Rear Door, Molding - Scratch - Minimal / (R) Front Door, Molding - Scratch - Minimal / (R) Front Fender, Molding - Crack, Gap - Small / Bonnet, Headlight - Scratch - Small / Member (Bolted) - Dent - Yes / Front Bumper, Grille, Lamps - Scratch - Small / (L) Front Fender, Molding - Scratch - Small / (L) Front Door, Molding - Scratch - Small</p>
