General Information

| Make | Toyota | Model | Vios |
| Registration No. | NHF1070 | Chassis No. | PA1B18F32P4219684 |

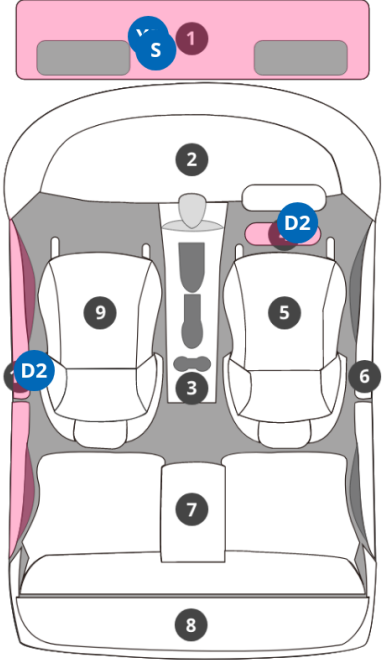
| <p>Remarks Ceiling - Grime - Small / Overall Interior - Smell - Yes / (L) Front Trim - Worked - Small / (L) Front Floor Mat - Worked - Small</p> | <p>Remarks (L) Rear Fender, Molding - Scratch - Small / (L) Rear Door, Molding - Scratch - Minimal / (L) Front Door, Molding - Scratch - Minimal / Bonnet, Headlight - Scratch - Minimal / Front Bumper, Grille, Lamps - Scratch - Medium / (R) Front Fender, Molding - Scratch - Minimal / (R) Front Door, Molding - Scratch - Small / (R) Rear Door, Molding - Scratch - Small / (R) Rear Fender, Molding - Scratch - Small / Rear Bumper, Lamps, Panels - Scratch - Small / Trunk Hood, Rear Gate - Scratch - Small / Roof - Scratch - Minimal</p> |
