## General Information

<b>Make</b>	Toyota	<b>Model</b>	Innova
<b>YOM</b>	2018	<b>Odo Meter Reading</b>	258,308
<b>Registration No.</b>	DAG1957	<b>Chassis No.</b>	PA2GW8EM7H3152178
<b>CC</b>	2.0	<b>Transmission</b>	A/T
<b>Fuel Type</b>	Gas	<b>Type of Body</b>	Wagon
<b>Colour</b>	White

## Body / Panel Condition

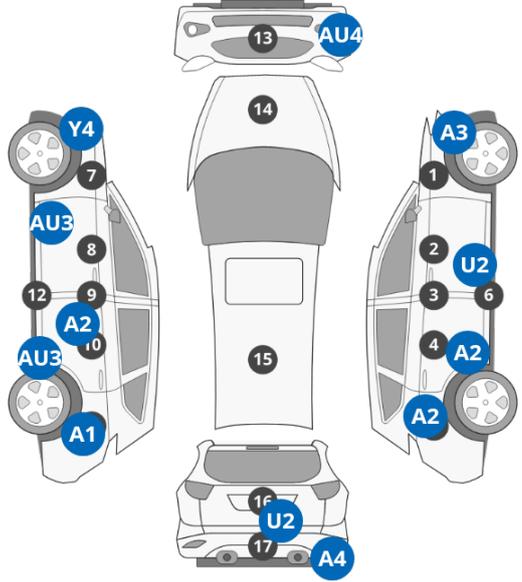
<p><b>A</b> : Scratch <b>AU</b> : Scratch &amp; Dent <b>B</b> : Modified <b>C</b> : Corrosion <b>G</b> : Stone chip <b>P</b> : Faded <b>S</b> : Rust <b>SC</b> : Rust &amp; Corrosion <b>U</b> : Dent <b>X</b> : Defective <b>Y</b> : Crack, Gap</p>
<p><b>Remarks</b>          Steering Wheel - Worn, Peel, Crack - Large / (R) Front Floor Mat - Missing - Yes / (L) Front Floor Mat - Missing - Yes / Mat Other - Missing - Yes / (L) Front Trim - Grime - Large / (R) Rear Trim - Grime - Medium / (L) Rear Trim - Grime - Small / (R) Front Trim - Grime - Small / Dashboard - Traces of Adhesive Tape - Yes</p>	<p><b>Remarks</b>          (R) Front Fender - Repair Traces - Yes / Bonnet - Repair Traces - Yes / (L) Front Fender - Repair Traces - Yes / Front Bumper, Grille, Lamps - Scratch &amp; Dent - Large / (R) Front Fender, Molding - Scratch - Medium / (R) Front Door, Molding - Dent - Small / (R) Rear Door, Molding - Scratch - Small / (R) Rear Fender, Molding - Scratch - Small / Rear Bumper, Lamps, Panels - Scratch - Large / Trunk Hood, Rear Gate - Dent - Small / (L) Front Door, Molding - Scratch &amp; Dent - Medium / (L) Step, In-panel, Side Spoiler - Scratch &amp; Dent - Medium / (L) Front Fender, Molding - Crack, Gap - Large / (L) Rear Door, Molding - Scratch - Small / (L) Rear Fender, Molding - Scratch - Minimal</p>
