## General Information

Date & Time: 17, Oct, 2025 16:49

<b>Make</b>	Toyota	<b>Model</b>	Vios
<b>YOM</b>	2023	<b>Odo Meter Reading</b>	48,723
<b>Registration No.</b>	FAO8905	<b>Chassis No.</b>	PA1B18F33P4220262
<b>CC</b>	1.3	<b>Transmission</b>	CVT
<b>Fuel Type</b>	Gas	<b>Type of Body</b>	Sedan
<b>Colour</b>	Red Mica Metallic

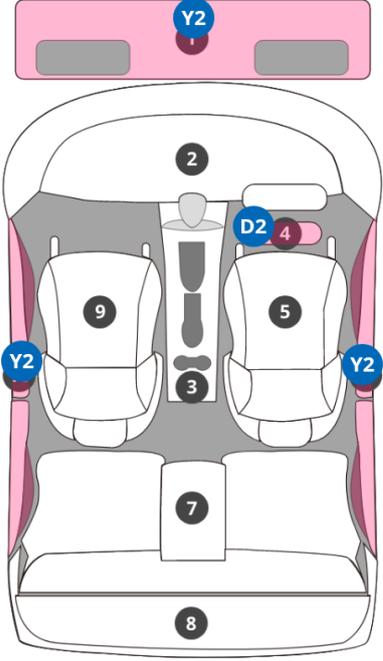
<b>Interior Evaluation :</b> <span style="float: right; color: red; font-weight: bold;">A</span>	<b>Exterior Evaluation :</b> <span style="float: right; color: red; font-weight: bold;">D</span>

<p><b>a</b> : Cut, Fray <b>d</b> : Loose, Deformed <b>k</b> : Animal Hair <b>s</b> : Smell <b>t</b> : Cigarette Burns <b>x</b> : Defective <b>y</b> : Stain</p>

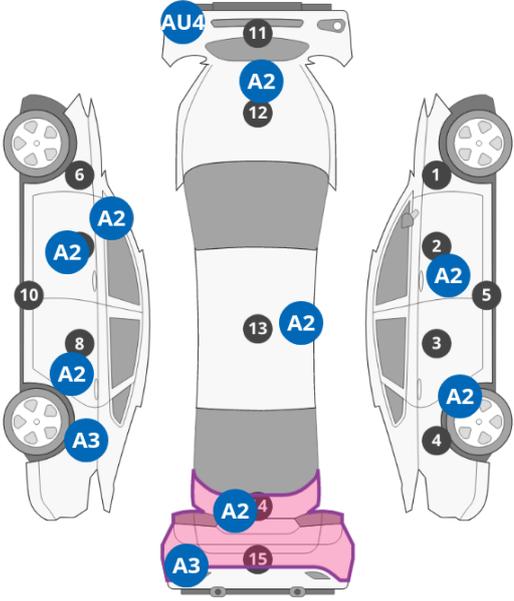
<p><b>A</b> : Scratch <b>AU</b> : Scratch &amp; Dent <b>B</b> : Modified <b>C</b> : Corrosion <b>G</b> : Stone chip <b>P</b> : Faded <b>S</b> : Rust <b>SC</b> : Rust &amp; Corrosion <b>U</b> : Dent <b>X</b> : Defective <b>Y</b> : Crack, Gap</p>
<p><b>Remarks</b> Ceiling - Grime - Small / (L) Front Trim - Grime - Small / (R) Front Trim - Grime - Small / (L) Front Floor Mat - Worked - Small</p>	<p><b>Remarks</b> Trunk Hood, Rear Gate - Repair Traces - Yes / Trunk Hood, Rear Gate - Repair mark - Yes / (L) Rear Door, Molding - Scratch - Small / (L) Rear Fender, Molding - Scratch - Medium / (L) Mirror - Scratch - Small / (L) Front Door, Molding - Scratch - Small / Front Bumper, Grille, Lamps - Scratch &amp; Dent - Large / Bonnet, Headlight - Scratch - Small / Roof - Scratch - Small / (R) Front Door, Molding - Scratch - Small / (R) Rear Fender, Molding - Scratch - Small / Trunk Hood, Rear Gate - Scratch - Small / Rear Bumper, Lamps, Panels - Scratch - Medium</p>
