## General Information

Date & Time: 14, Oct, 2025 20:57

<b>Make</b>	Toyota	<b>Model</b>	Vios
<b>YOM</b>	2024	<b>Odo Meter Reading</b>	25,891
<b>Registration No.</b>	FAQ1998	<b>Chassis No.</b>	PA1B18F37P4226193
<b>CC</b>	1.3	<b>Transmission</b>	CVT
<b>Fuel Type</b>	Gas	<b>Type of Body</b>	Sedan
<b>Colour</b>	Black

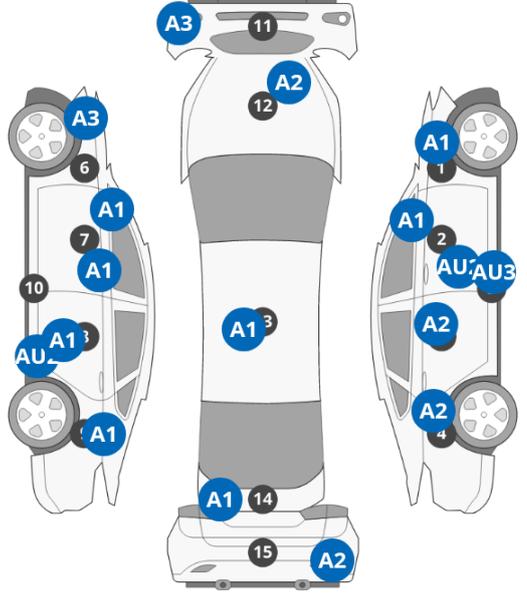
<p><b>A</b> : Scratch <b>AU</b> : Scratch &amp; Dent <b>B</b> : Modified <b>C</b> : Corrosion <b>G</b> : Stone chip <b>P</b> : Faded <b>S</b> : Rust <b>SC</b> : Rust &amp; Corrosion <b>U</b> : Dent <b>X</b> : Defective <b>Y</b> : Crack, Gap</p>
<p><b>Remarks</b> (L) Front Trim - Grime - Small / (R) Front Trim - Grime - Small / (L) Front Floor Mat - Worked - Small / Ceiling - Grime - Minimal</p>	<p><b>Remarks</b> (R) Mirror - Scratch - Minimal / (R) Front Door, Molding - Scratch &amp; Dent - Small / (R) Step, In-panel, Side Spoiler - Scratch &amp; Dent - Medium / (R) Front Fender, Molding - Scratch - Minimal / (R) Rear Fender, Molding - Scratch - Small / (R) Rear Door, Molding - Scratch - Small / Rear Bumper, Lamps, Panels - Scratch - Small / Trunk Hood, Rear Gate - Scratch - Minimal / (L) Step, In-panel, Side Spoiler - Scratch &amp; Dent - Small / (L) Rear Fender, Molding - Scratch - Minimal / (L) Rear Door, Molding - Scratch - Minimal / (L) Front Door, Molding - Scratch - Minimal / (L) Mirror - Scratch - Minimal / (L) Front Fender, Molding - Scratch - Medium / Front Bumper, Grille, Lamps - Scratch - Medium / Bonnet, Headlight - Scratch - Small / Roof - Scratch - Minimal</p>
