General Information

| Make | Toyota | Model | Vios |
| Registration No. | FAQ2064 | Chassis No. | PA1B18F3XP4225409 |

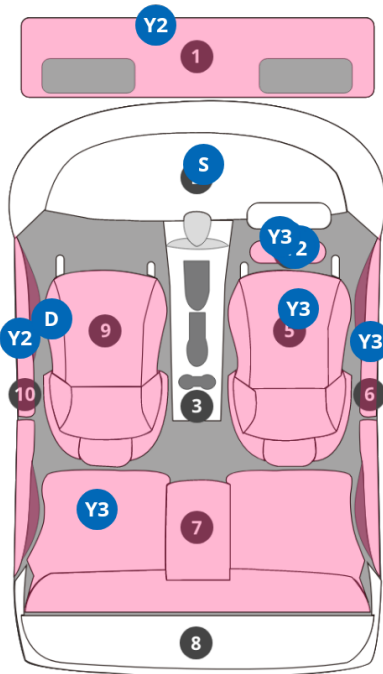
| Interior Evaluation : D | Exterior Evaluation : E |

| Remarks Overall Interior - Smell - Yes / (R) Front Floor Mat - Grime - Medium / (R) Front Trim - Grime - Medium / (L) Front Trim - Grime - Small / (L) Front Floor Mat - Worked - Small / (L) Front Floor Mat - Grime - Small / Ceiling - Grime - Small / Mat Other - Grime - Medium / Rear Seat - Grime - Medium / (R) Front Seat - Grime - Medium / (L) Front Seat - Worn - Yes | Remarks (L) Front Fender - Repair Traces - Yes / Roof - Dent - Medium / (R) Front Door, Molding - Repair mark - Yes / (R) Rear Door, Molding - Repair mark - Yes / (R) Front Fender, Molding - Repair mark - Yes / (R) Front Door, Molding - Scratch & Dent - Large / (R) Rear Door, Molding - Scratch & Dent - Medium / (R) Rear Fender, Molding - Scratch - Small / Rear Bumper, Lamps, Panels - Repair mark - Yes / Rear Bumper, Lamps, Panels - Scratch - Small / Trunk Hood, Rear Gate - Scratch - Small / (L) Rear Fender, Molding - Scratch - Minimal / (L) Rear Door, Molding - Scratch - Minimal / (L) Front Door, Molding - Scratch & Dent - Small / (L) Front Door, Molding - Repair mark - Yes / (L) Front Fender, Molding - Scratch - Minimal / (L) Mirror - Scratch - Minimal / Front Bumper, Grille, Lamps - Scratch - Medium / Bonnet, Headlight - Scratch - Small / (R) Front Fender, Molding - Scratch & Dent - Medium |
