## General Information

| Make | Toyota | Model | Vios |
| Registration No. | FAR1578 | Chassis No. | PA1B18F36P4234866 |

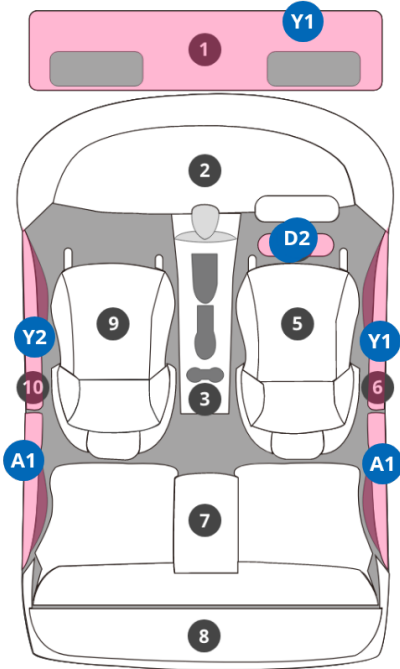
| Interior Evaluation : <b>B</b> | Exterior Evaluation : <b>C</b> |
| <p><b>Remarks</b><br/>Ceiling - Grime - Minimal / (L) Front Trim - Grime - Small / (L) Rear Trim - Cut, Crack - Minimal / (R) Rear Trim - Cut, Crack - Minimal / (R) Front Trim - Grime - Minimal / Mat Other - Grime - Small / (L) Front Floor Mat - Worked - Small</p> | <p><b>Remarks</b><br/>(R) Front Fender, Molding - Scratch - Minimal / (R) Mirror - Scratch - Minimal / (R) Front Door, Molding - Scratch - Small / (R) Rear Door, Molding - Scratch - Medium / Trunk Hood, Rear Gate - Scratch - Minimal / Rear Bumper, Lamps, Panels - Scratch - Minimal / (L) Rear Fender, Molding - Scratch - Minimal / (L) Rear Door, Molding - Scratch - Small / (L) Front Door, Molding - Scratch - Small / (L) Front Fender, Molding - Scratch &amp; Dent - Small / Front Bumper, Grille, Lamps - Scratch &amp; Dent - Medium / Bonnet, Headlight - Scratch - Minimal / Roof - Scratch - Minimal</p> |

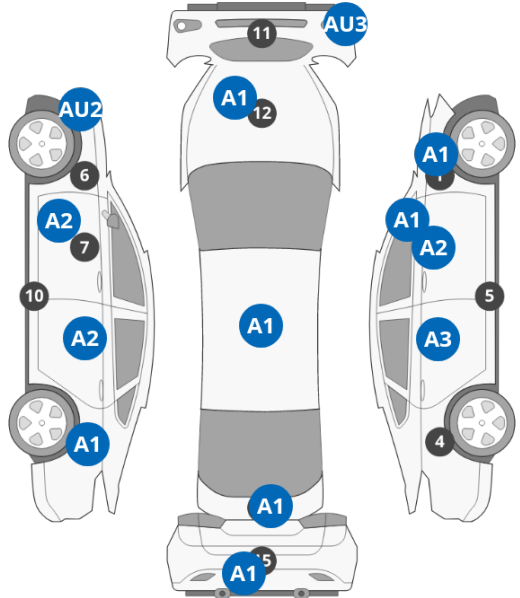
| Inspector Notes |
|---|
| with warranty booklet, with jack, no tools, with spare tire, with LTO plate, scratched and cracked tail light |
