## General Information

<b>Make</b>	Toyota	<b>Model</b>	Wigo
<b>YOM</b>	2025	<b>Odo Meter Reading</b>	2,930
<b>Registration No.</b>	GBF6993	<b>Chassis No.</b>	MHKAA1BC9RJ026723
<b>CC</b>	1.0	<b>Transmission</b>	CVT
<b>Fuel Type</b>	Gas	<b>Type of Body</b>	Hatchback
<b>Colour</b>	Gray

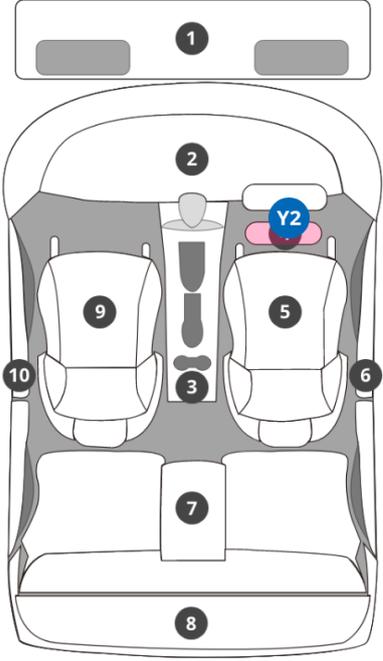
<b>Interior Evaluation :</b> <span style="color: red; font-weight: bold; font-size: 1.2em;">A</span>	<b>Exterior Evaluation :</b> <span style="color: red; font-weight: bold; font-size: 1.2em;">C</span>

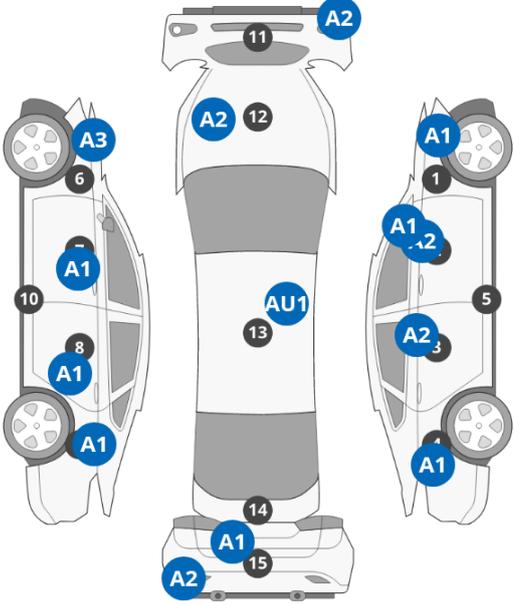
<p><b>A</b> : Scratch <b>AU</b> : Scratch &amp; Dent <b>B</b> : Modified <b>C</b> : Corrosion <b>G</b> : Stone chip <b>P</b> : Faded <b>S</b> : Rust <b>SC</b> : Rust &amp; Corrosion <b>U</b> : Dent <b>X</b> : Defective <b>Y</b> : Crack, Gap</p>
<p><b>Remarks</b> (L) Front Floor Mat - Grime - Small</p>	<p><b>Remarks</b> (R) Front Fender, Molding - Scratch - Minimal / (R) Front Door, Molding - Scratch - Small / (R) Mirror - Scratch - Minimal / (R) Rear Door, Molding - Scratch - Small / (R) Rear Fender, Molding - Scratch - Minimal / Rear Bumper, Lamps, Panels - Scratch - Small / Trunk Hood, Rear Gate - Scratch - Minimal / (L) Front Door, Molding - Scratch - Minimal / (L) Rear Door, Molding - Scratch - Minimal / (L) Rear Fender, Molding - Scratch - Minimal / (L) Front Fender, Molding - Scratch - Medium / Front Bumper, Grille, Lamps - Scratch - Small / Bonnet, Headlight - Scratch - Small / Roof - Scratch &amp; Dent - Minimal</p>

<p><b>Inspector Notes</b></p>
<p>with warranty booklet and jack, no tools, with spare tire, with LTO plate, scratches on tail light</p>
