## General Information

<b>Make</b>	Suzuki	<b>Model</b>	Dzire
<b>YOM</b>	2025	<b>Odo Meter Reading</b>	9,627
<b>Registration No.</b>	GBJ3100	<b>Chassis No.</b>	MBHZF63S8SG585520
<b>CC</b>	1.2	<b>Transmission</b>	A/T
<b>Fuel Type</b>	Gas	<b>Type of Body</b>	Sedan
<b>Colour</b>	Blue

## Body / Panel Condition

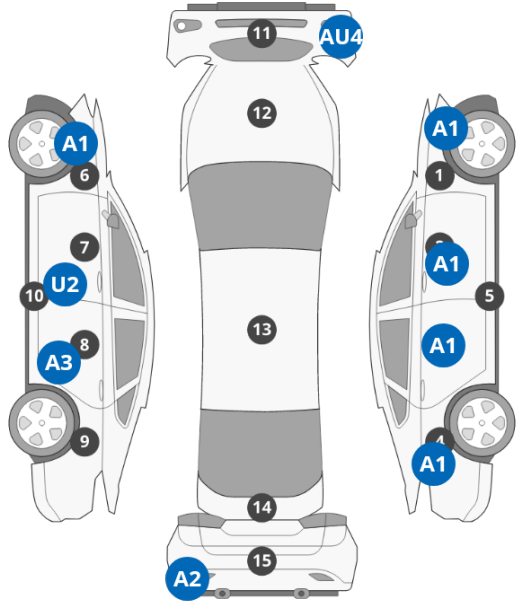
<p><b>A</b> : Scratch <b>AU</b> : Scratch &amp; Dent <b>B</b> : Modified <b>C</b> : Corrosion <b>G</b> : Stone chip <b>P</b> : Faded <b>S</b> : Rust <b>SC</b> : Rust &amp; Corrosion <b>U</b> : Dent <b>X</b> : Defective <b>Y</b> : Crack, Gap</p>
<p><b>Remarks</b> (R) Front Seat - Grime - Large / (L) Front Floor Mat - Worked - Large / (L) Front Seat - Grime - Small / (L) Front Trim - Grime - Small</p>	<p><b>Remarks</b> Front Bumper, Grille, Lamps - Scratch &amp; Dent - Large / (L) Front Door, Molding - Dent - Small / (L) Rear Door, Molding - Scratch - Medium / Rear Bumper, Lamps, Panels - Scratch - Small / (R) Rear Fender, Molding - Scratch - Minimal / (R) Rear Door, Molding - Scratch - Minimal / (R) Front Door, Molding - Scratch - Minimal / (L) Front Fender, Molding - Scratch - Minimal / (R) Front Fender, Molding - Scratch - Minimal</p>
