## General Information

Date & Time: 17, Oct, 2025 16:49

<b>Make</b>	Toyota	<b>Model</b>	Vios
<b>YOM</b>	2023	<b>Odo Meter Reading</b>	29,224
<b>Registration No.</b>	Z5O914	<b>Chassis No.</b>	PA1B18F33P4218527
<b>CC</b>	1.3	<b>Transmission</b>	M/T
<b>Fuel Type</b>	Gas	<b>Type of Body</b>	Sedan
<b>Colour</b>	Green

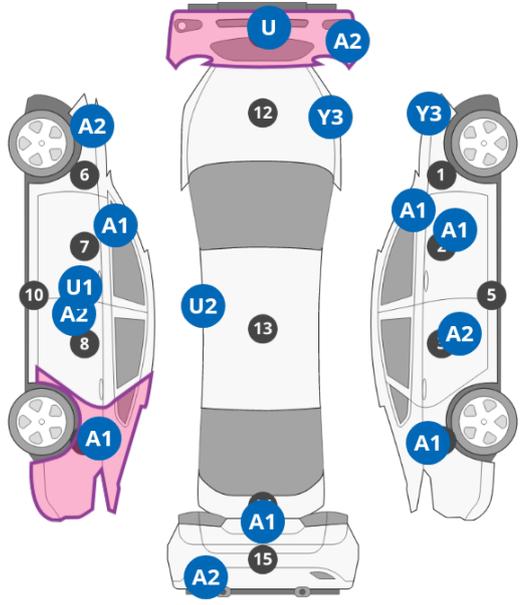
<p><b>A</b> : Scratch <b>AU</b> : Scratch &amp; Dent <b>B</b> : Modified <b>C</b> : Corrosion <b>G</b> : Stone chip <b>P</b> : Faded <b>S</b> : Rust <b>SC</b> : Rust &amp; Corrosion <b>U</b> : Dent <b>X</b> : Defective <b>Y</b> : Crack, Gap</p>
<p><b>Remarks</b> (R) Front Floor Mat - Grime - Small / Rear Seat - Grime - Medium / (L) Front Seat - Worn - Yes / (L) Front Trim - Grime - Small / (R) Front Trim - Grime - Small / (R) Front Seat - Grime - Minimal</p>	<p><b>Remarks</b> (R) Front Fender - Repair Traces - Yes / Bonnet - Repair Traces - Yes / (R) Rear Fender - Repair Traces - Yes / (R) Rear Door - Repair Traces - Yes / Front Bumper, Grille, Lamps - Repair mark - Yes / (R) Front Fender, Molding - Crack, Gap - Medium / (R) Mirror - Scratch - Minimal / (R) Front Door, Molding - Scratch - Minimal / (R) Rear Door, Molding - Scratch - Small / (R) Rear Fender, Molding - Scratch - Minimal / Rear Bumper, Lamps, Panels - Scratch - Small / Trunk Hood, Rear Gate - Scratch - Minimal / (L) Rear Fender, Molding - Repair mark - Yes / (L) Rear Fender, Molding - Scratch - Minimal / (L) Rear Door, Molding - Scratch - Small / (L) Front Door, Molding - Dent - Minimal / (L) Mirror - Scratch - Minimal / (L) Front Fender, Molding - Scratch - Small / Member (Bolted) - Dent - Yes / Front Bumper, Grille, Lamps - Scratch - Small / Bonnet, Headlight - Crack, Gap - Medium / Roof - Dent - Small</p>
