## General Information

<b>Make</b>	Toyota	<b>Model</b>	Hiace
<b>YOM</b>	2024	<b>Odo Meter Reading</b>	28,416
<b>Registration No.</b>	DBQ7247	<b>Chassis No.</b>	JTFNAFAP9P8040257
<b>CC</b>	2.8	<b>Transmission</b>	M/T
<b>Fuel Type</b>	Diesel	<b>Type of Body</b>	Van
<b>Colour</b>	Silver

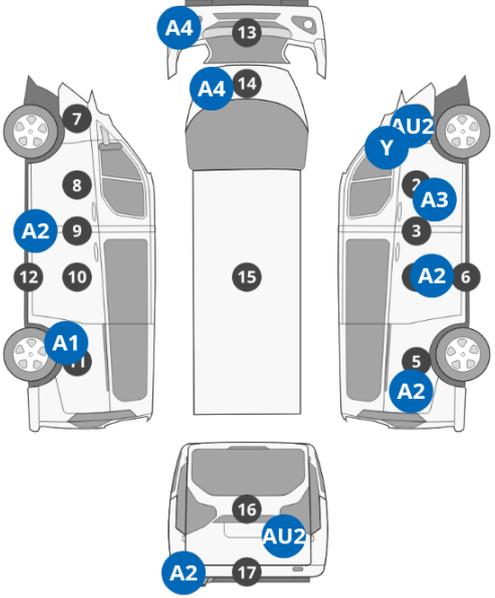
<p><b>A</b> : Scratch <b>AU</b> : Scratch &amp; Dent <b>B</b> : Modified <b>C</b> : Corrosion <b>G</b> : Stone chip <b>P</b> : Faded <b>S</b> : Rust <b>SC</b> : Rust &amp; Corrosion <b>U</b> : Dent <b>X</b> : Defective <b>Y</b> : Crack, Gap</p>
<p><b>Remarks</b> Ceiling - Grime - Small / Mat Other - Missing - Yes / (L) Front Seat - Grime - Minimal</p>	<p><b>Remarks</b> (R) Rear Fender - Repair Traces - Yes / (R) Rear Door - Repair Traces - Yes / (R) Front Door, Molding - Scratch - Medium / (R) Front Fender, Molding - Scratch &amp; Dent - Small / (R) Rear Door, Molding - Scratch - Small / (R) Rear Fender, Molding - Scratch - Small / Trunk Hood, Rear Gate - Scratch &amp; Dent - Small / Rear Bumper, Lamps, Panels - Scratch - Small / (L) Center Panel - Scratch - Small / (L) Rear Fender, Molding - Scratch - Minimal / Bonnet, Headlight - Scratch - Large / Front Bumper, Grille, Lamps - Scratch - Large / (R) Mirror - Crack - Damaged</p>

<p><b>Inspector Notes</b></p>
<p>Right side mirror crack. With warranty booklet. Without spare tire,jack and tools. 1 key. With LTO plate.</p>
