## General Information

Date & Time: 19, Jan, 2026 09:45

<b>Make</b>	Toyota	<b>Model</b>	Vios
<b>YOM</b>	2024	<b>Odo Meter Reading</b>	1,527
<b>Registration No.</b>	GBE7079	<b>Chassis No.</b>	PA1B18F35R4257140
<b>CC</b>	1.3	<b>Transmission</b>	CVT
<b>Fuel Type</b>	Gas	<b>Type of Body</b>	Sedan
<b>Colour</b>	Silver

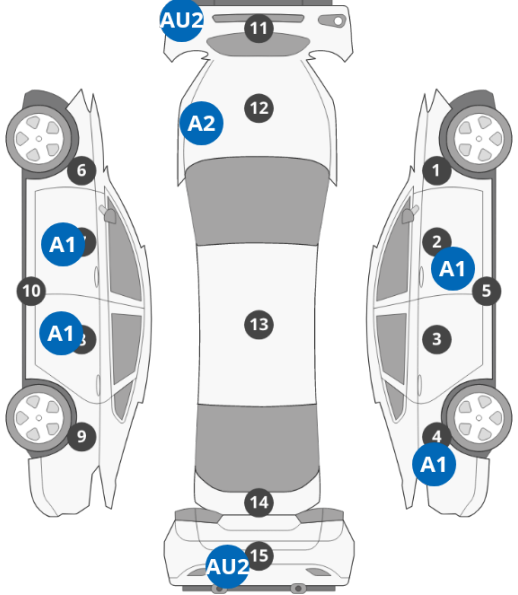
<p><b>A</b> : Scratch <b>AU</b> : Scratch &amp; Dent <b>B</b> : Modified <b>C</b> : Corrosion <b>G</b> : Stone chip <b>P</b> : Faded <b>S</b> : Rust <b>SC</b> : Rust &amp; Corrosion <b>U</b> : Dent <b>X</b> : Defective <b>Y</b> : Crack, Gap</p>
<p><b>Remarks</b> (L) Front Floor Mat - Grime - Large / (L) Front Trim - Grime - Small / Ceiling - Grime - Small / Mat Other - Grime - Medium / (R) Front Floor Mat - Grime - Medium / (R) Front Trim - Grime - Small / Dashboard - Traces of Adhesive Tape - Yes</p>	<p><b>Remarks</b> (L) Front Door, Molding - Scratch - Minimal / (L) Rear Door, Molding - Scratch - Minimal / Rear Bumper, Lamps, Panels - Scratch &amp; Dent - Small / (R) Rear Fender, Molding - Scratch - Minimal / (R) Front Door, Molding - Scratch - Minimal / Bonnet, Headlight - Scratch - Small / Front Bumper, Grille, Lamps - Scratch &amp; Dent - Small</p>
