## General Information

<b>Make</b>	Toyota	<b>Model</b>	Vios
<b>YOM</b>	2025	<b>Odo Meter Reading</b>	41,596
<b>Registration No.</b>	GBF1831	<b>Chassis No.</b>	PA1B18F34R4261891
<b>CC</b>	1.3	<b>Transmission</b>	CVT
<b>Fuel Type</b>	Gas	<b>Type of Body</b>	Sedan
<b>Colour</b>	Red Mica Metallic

## Body / Panel Condition

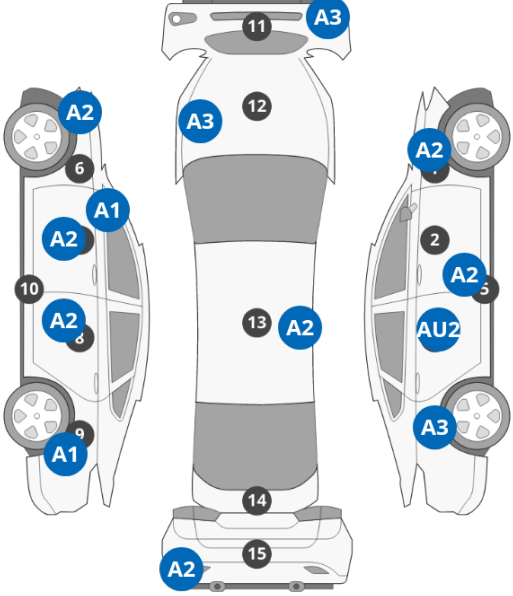
<p><b>A</b> : Scratch <b>AU</b> : Scratch &amp; Dent <b>B</b> : Modified <b>C</b> : Corrosion <b>G</b> : Stone chip <b>P</b> : Faded <b>S</b> : Rust <b>SC</b> : Rust &amp; Corrosion <b>U</b> : Dent <b>X</b> : Defective <b>Y</b> : Crack, Gap</p>
<p><b>Remarks</b> Ceiling - Grime - Small / (R) Front Floor Mat - Grime - Small / (R) Front Trim - Grime - Small / (L) Front Trim - Grime - Small / (L) Front Floor Mat - Worked - Small / Dashboard - Traces of Adhesive Tape - Yes</p>	<p><b>Remarks</b> (R) Rear Door, Molding - Scratch &amp; Dent - Small / (R) Front Door, Molding - Scratch - Small / (R) Front Fender, Molding - Scratch - Small / (R) Rear Fender, Molding - Scratch - Medium / Rear Bumper, Lamps, Panels - Scratch - Small / (L) Rear Fender, Molding - Scratch - Minimal / (L) Rear Door, Molding - Scratch - Small / (L) Front Door, Molding - Scratch - Small / (L) Mirror - Scratch - Minimal / (L) Front Fender, Molding - Scratch - Small / Bonnet, Headlight - Scratch - Medium / Front Bumper, Grille, Lamps - Scratch - Medium / Roof - Scratch - Small</p>
