## General Information

<b>Make</b>	Toyota	<b>Model</b>	Vios
<b>YOM</b>	2023	<b>Odo Meter Reading</b>	31,874
<b>Registration No.</b>	GAK3654	<b>Chassis No.</b>	PA1B18F37P4206185
<b>CC</b>	1.3	<b>Transmission</b>	M/T
<b>Fuel Type</b>	Gas	<b>Type of Body</b>	Sedan
<b>Colour</b>	Silver

## Body / Panel Condition

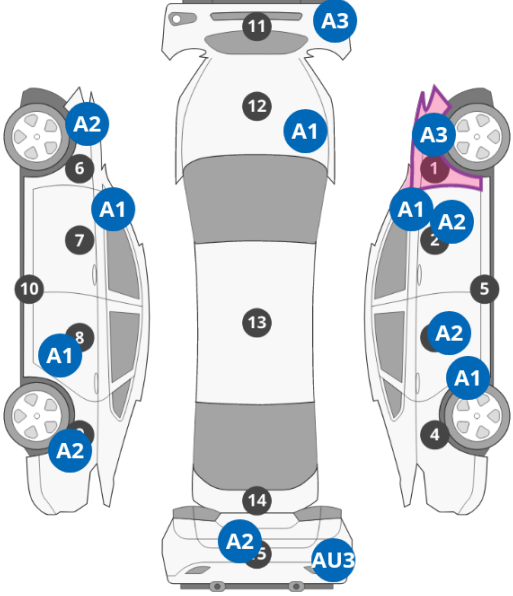
<p><b>A</b> : Scratch <b>AU</b> : Scratch &amp; Dent <b>B</b> : Modified <b>C</b> : Corrosion <b>G</b> : Stone chip <b>P</b> : Faded <b>S</b> : Rust <b>SC</b> : Rust &amp; Corrosion <b>U</b> : Dent <b>X</b> : Defective <b>Y</b> : Crack, Gap</p>
<p><b>Remarks</b> Ceiling - Grime - Medium / (R) Front Trim - Grime - Small / (R) Front Floor Mat - Grime - Small / Mat Other - Grime - Small / (L) Front Trim - Grime - Small / (L) Front Floor Mat - Grime - Small</p>	<p><b>Remarks</b> (L) Front Fender, Molding - Scratch - Small / Front Bumper, Grille, Lamps - Scratch - Medium / Bonnet, Headlight - Scratch - Minimal / (R) Front Fender, Molding - Scratch - Medium / (R) Mirror - Scratch - Minimal / (R) Front Door, Molding - Scratch - Small / (R) Rear Door, Molding - Scratch - Small / (R) Rear Fender, Molding - Scratch - Minimal / Rear Bumper, Lamps, Panels - Scratch &amp; Dent - Medium / Trunk Hood, Rear Gate - Scratch - Small / (L) Rear Fender, Molding - Scratch - Small / (L) Rear Door, Molding - Scratch - Minimal / (L) Mirror - Scratch - Minimal / (R) Front Wheel, Cover - Cap Missing - Yes</p>
