## General Information

<b>Make</b>	Toyota	<b>Model</b>	Avanza
<b>YOM</b>	2024	<b>Odo Meter Reading</b>	19,272
<b>Registration No.</b>	HAG7405	<b>Chassis No.</b>	MHFAA1BY0P0019432
<b>CC</b>	1.3	<b>Transmission</b>	M/T
<b>Fuel Type</b>	Gas	<b>Type of Body</b>	MPV
<b>Colour</b>	White

## Body / Panel Condition

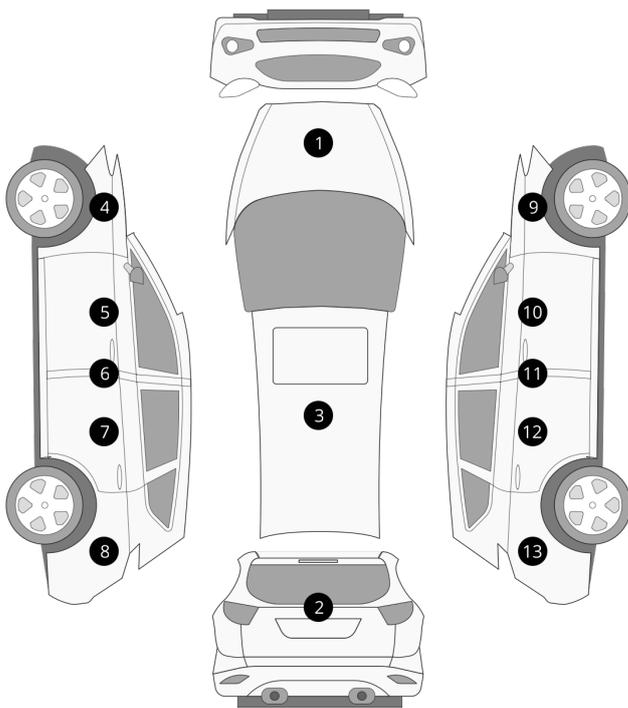
#	Area	Thickness(um)			
		Average	Value1	Value2	Value3/4
1	Bonnet	82.9	83	80	86
2	Boot Lid	85.3	87	86	83
3	Roof	107.2	98	96	127/108
4	Left Front Fender	93.6	93	93	95
5	Left Front Door	102.0	98	94	114
6	Center Panel Left				
7	Left Rear Door	101.3	103	101	100
8	Left Back Panel	106.8	118	106	97
9	Right Front Fender	88.2	94	90	80
10	Right Front Door	107.0	116	105	100
11	Center Panel Right				
12	Right Rear Door	104.3	102	99	112
13	Right Back Panel	100.4	100	93	108

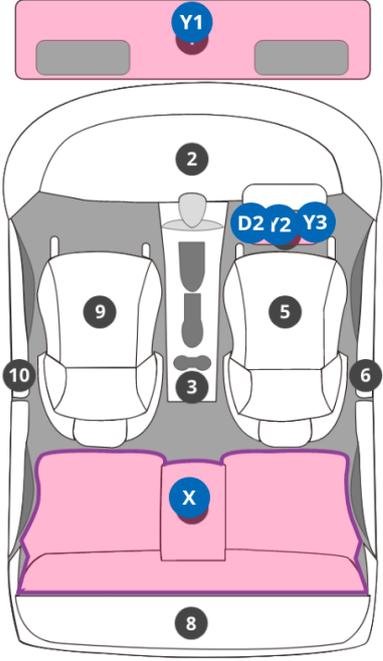
<p><b>A</b> : Scratch <b>AU</b> : Scratch &amp; Dent <b>B</b> : Modified <b>C</b> : Corrosion <b>G</b> : Stone chip <b>P</b> : Faded <b>S</b> : Rust <b>SC</b> : Rust &amp; Corrosion <b>U</b> : Dent <b>X</b> : Defective <b>Y</b> : Crack, Gap</p>
<p><b>Remarks</b> (R) Front Floor Mat - Grime - Medium / Mat Other - Grime - Small / Rear Seat - Partially Missing - Yes / (L) Front Floor Mat - Worked - Small / Ceiling - Grime - Minimal</p>	<p><b>Remarks</b> (R) Front Fender, Molding - Scratch - Small / (R) Front Door, Molding - Scratch - Medium / (R) Rear Door, Molding - Scratch - Minimal / Rear Bumper, Lamps, Panels - Scratch &amp; Dent - Medium / (L) Rear Fender, Molding - Scratch - Minimal / (L) Rear Door, Molding - Scratch - Small / (L) Mirror - Scratch - Minimal / Bonnet, Headlight - Scratch - Small / Front Bumper, Grille, Lamps - Scratch - Small</p>
