## General Information

| Make | Toyota | Model | Innova |
| Registration No. | DAD3517 | Chassis No. | PA2JA8EM1J0050533 |

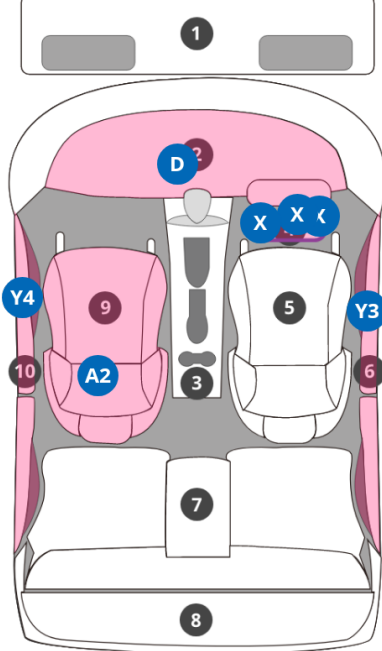
| Interior Evaluation : <b>C</b> | Exterior Evaluation : <b>E</b> |
|---|---|
| <p><b>Remarks</b></p> <p>Mat Other - Missing - Yes / (L) Front Floor Mat - Missing - Yes / (R) Front Floor Mat - Missing - Yes / (R) Front Trim - Grime - Medium / (L) Front Trim - Grime - Large / Dashboard - Traces of Adhesive Tape - Yes / (L) Front Seat - Cut, Crack - Small</p> | <p><b>Remarks</b></p> <p>(R) Front Door - Repair Traces - Yes / (R) Step - Repair Traces - Yes / (R) Front Fender - Repair Traces - Yes / Bonnet - Repair Traces - Yes / (L) Front Fender - Repair Traces - Yes / (L) Front Door - Repair Traces - Yes / (L) Step - Repair Traces - Yes / (L) Rear Door - Repair Traces - Yes / (L) Rear Fender - Repair Traces - Yes / Trunk Hood, Rear Gate - Repair Traces - Yes / (R) Rear Fender - Repair Traces - Yes / (R) Rear Door - Repair Traces - Yes / Roof - Repair Traces - Yes / Bonnet, Headlight - Repair mark - Yes / (R) Rear Fender, Molding - Scratch &amp; Dent - Large / Rear Bumper, Lamps, Panels - Scratch &amp; Dent - Large / Trunk Hood, Rear Gate - Dent - Small / (L) Front Door, Molding - Dent - Small / (L) Rear Door, Molding - Scratch - Small / (L) Rear Fender, Molding - Dent - Small / Bonnet, Headlight - Dent - Small / Front Bumper, Grille, Lamps - Scratch &amp; Dent - Large / (R) Front Fender, Molding - Scratch &amp; Dent - Small / (R) Rear Door, Molding - Scratch &amp; Dent - Small / (R) Front Door, Molding - Scratch - Small / (R) Step, In-panel, Side Spoiler - Scratch - Small / (L) Step, In-panel, Side Spoiler - Scratch - Small / Roof - Dent - Small</p> |
