## General Information

| Make | Nissan | Model | Almera |
| Registration No. | NCR8747 | Chassis No. | BDUALBAN17C03772 |

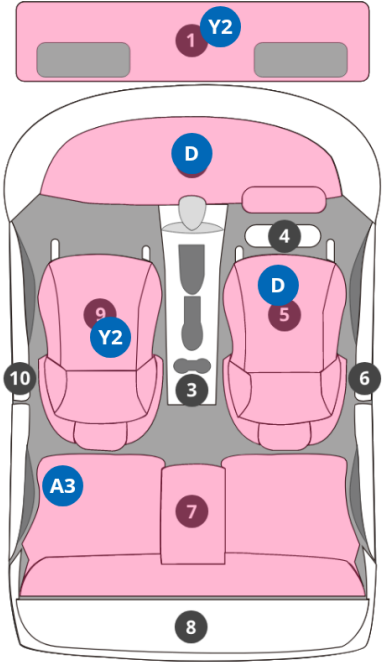
| Interior Evaluation : <b>B</b> | Exterior Evaluation : <b>D</b> |
|---|---|
| <p><b>Remarks</b></p> <p>Rear Seat - Cut, Crack - Medium / Ceiling - Grime - Small / Dashboard - Traces of Adhesive Tape - Yes / (R) Front Seat - Worn - Yes / (L) Front Seat - Grime - Small</p> | <p><b>Remarks</b></p> <p>(R) Front Door - Repair Traces - Yes / Bonnet - Repair Traces - Yes / (L) Rear Door - Repair Traces - Yes / (R) Rear Fender - Repair Traces - Yes / (R) Rear Door - Repair Traces - Yes / (R) Front Door, Molding - Repair mark - Yes / (R) Rear Door, Molding - Repair mark - Yes / (R) Rear Fender, Molding - Repair mark - Yes / Roof - Repair mark - Yes / Bonnet, Headlight - Repair mark - Yes / (L) Front Fender, Molding - Repair mark - Yes / (L) Rear Door, Molding - Repair mark - Yes / Trunk Hood, Rear Gate - Scratch - Small / Rear Bumper, Lamps, Panels - Scratch - Small / (R) Rear Fender, Molding - Scratch - Minimal / (R) Rear Door, Molding - Scratch &amp; Dent - Minimal / (R) Front Door, Molding - Dent - Minimal / (R) Front Fender, Molding - Scratch - Small / (R) Mirror - Scratch - Minimal / (R) Step, In-panel, Side Spoiler - Scratch &amp; Dent - Small / Bonnet, Headlight - Scratch - Small / Front Bumper, Grille, Lamps - Scratch - Small / (L) Mirror - Scratch - Minimal / (L) Front Fender, Molding - Scratch - Small / (L) Front Door, Molding - Dent - Minimal / (L) Rear Door, Molding - Scratch - Small / (L) Step, In-panel, Side Spoiler - Scratch &amp; Dent - Minimal / (L) Rear Fender, Molding - Scratch - Minimal / Roof - Scratch - Minimal</p> |
