## General Information

<b>Make</b>	Toyota	<b>Model</b>	Vios
<b>YOM</b>	2023	<b>Odo Meter Reading</b>	29,984
<b>Registration No.</b>	CBI7093-1	<b>Chassis No.</b>	PA1B18F31P4218574
<b>CC</b>	1.3	<b>Transmission</b>	CVT
<b>Fuel Type</b>	Gas	<b>Type of Body</b>	Sedan
<b>Colour</b>	Black

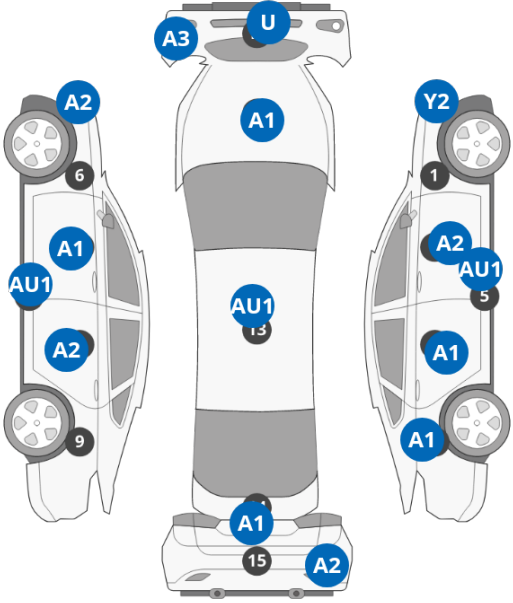
<p><b>A</b> : Scratch <b>AU</b> : Scratch &amp; Dent <b>B</b> : Modified <b>C</b> : Corrosion <b>G</b> : Stone chip <b>P</b> : Faded <b>S</b> : Rust <b>SC</b> : Rust &amp; Corrosion <b>U</b> : Dent <b>X</b> : Defective <b>Y</b> : Crack, Gap</p>
<p><b>Remarks</b> Rear Seat - Grime - Small / (R) Front Seat - Grime - Small / (L) Front Seat - Grime - Small / (L) Front Floor Mat - Worked - Small / (L) Front Trim - Worked - Small / Ceiling - Grime - Small / Overall Interior - Smell - Yes</p>	<p><b>Remarks</b> Member (Bolted) - Dent - Yes / (L) Front Fender, Molding - Scratch - Small / Front Bumper, Grille, Lamps - Scratch - Medium / (L) Rear Door, Molding - Scratch - Small / (L) Front Door, Molding - Scratch - Minimal / Trunk Hood, Rear Gate - Scratch - Minimal / Rear Bumper, Lamps, Panels - Scratch - Small / (R) Rear Door, Molding - Scratch - Minimal / (R) Rear Fender, Molding - Scratch - Minimal / (R) Front Fender, Molding - Crack, Gap - Small / (R) Front Door, Molding - Scratch - Small / (R) Step, In-panel, Side Spoiler - Scratch &amp; Dent - Minimal / Roof - Scratch &amp; Dent - Minimal / Bonnet, Headlight - Scratch - Minimal / (L) Step, In-panel, Side Spoiler - Scratch &amp; Dent - Minimal</p>
