## General Information

<b>Make</b>	Toyota	<b>Model</b>	Vios
<b>YOM</b>	2025	<b>Odo Meter Reading</b>	12,381
<b>Registration No.</b>	CCF6502	<b>Chassis No.</b>	PA1B18F37R4270696
<b>CC</b>	1.3	<b>Transmission</b>	CVT
<b>Fuel Type</b>	Gas	<b>Type of Body</b>	Sedan
<b>Colour</b>	Silver

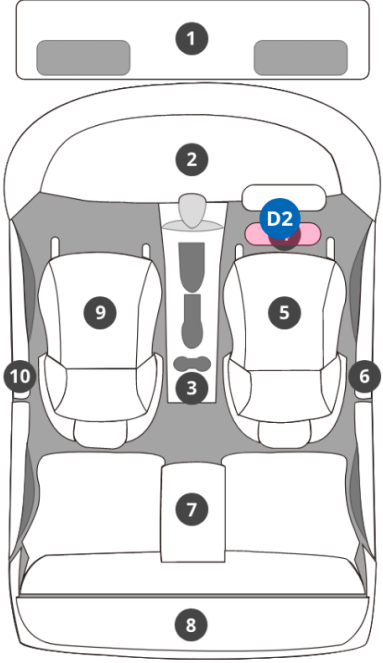
<p><b>a</b> : Cut, Fray <b>d</b> : Loose, Deformed <b>k</b> : Animal Hair <b>s</b> : Smell <b>t</b> : Cigarette Burns <b>x</b> : Defective <b>y</b> : Stain</p>

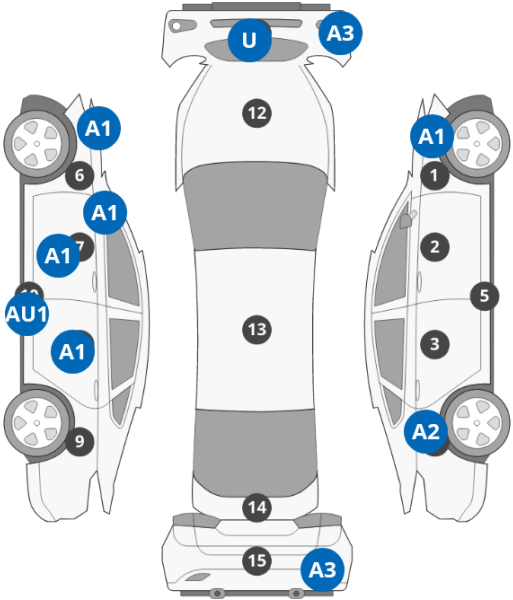
<p><b>A</b> : Scratch <b>AU</b> : Scratch &amp; Dent <b>B</b> : Modified <b>C</b> : Corrosion <b>G</b> : Stone chip <b>P</b> : Faded <b>S</b> : Rust <b>SC</b> : Rust &amp; Corrosion <b>U</b> : Dent <b>X</b> : Defective <b>Y</b> : Crack, Gap</p>
<b>Remarks</b> (L) Front Floor Mat - Worked - Small	<b>Remarks</b> (L) Front Fender, Molding - Scratch - Minimal / (L) Front Door, Molding - Scratch - Minimal / (L) Rear Door, Molding - Scratch - Minimal / (L) Step, In-panel, Side Spoiler - Scratch & Dent - Minimal / (L) Mirror - Scratch - Minimal / Member (Bolted) - Dent - Yes / Front Bumper, Grille, Lamps - Scratch - Medium / (R) Front Fender, Molding - Scratch - Minimal / (R) Rear Fender, Molding - Scratch - Small / Rear Bumper, Lamps, Panels - Scratch - Medium
