## General Information

<b>Make</b>	Toyota	<b>Model</b>	Hiace
<b>YOM</b>	2021	<b>Odo Meter Reading</b>	99,236
<b>Registration No.</b>	NEX9561	<b>Chassis No.</b>	JTFJT02P9M5028384
<b>CC</b>	3.0	<b>Transmission</b>	M/T
<b>Fuel Type</b>	Diesel	<b>Type of Body</b>	Van
<b>Colour</b>	White

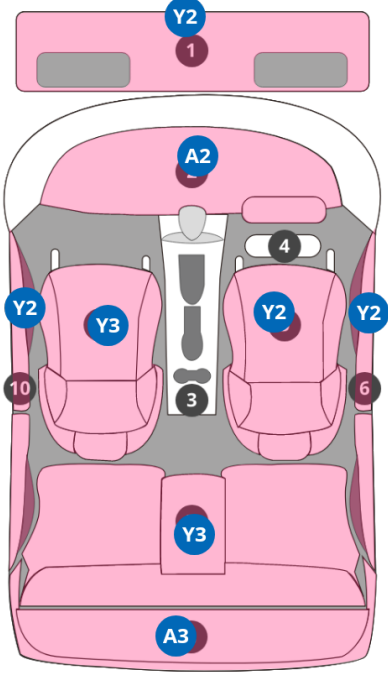
<b>Interior Evaluation :</b> <span style="float: right; color: red; font-weight: bold;">C</span>	<b>Exterior Evaluation :</b> <span style="float: right; color: red; font-weight: bold;">E</span>

<p><b>a</b> : Cut, Fray <b>d</b> : Loose, Deformed <b>k</b> : Animal Hair <b>s</b> : Smell <b>t</b> : Cigarette Burns <b>x</b> : Defective <b>y</b> : Stain</p>

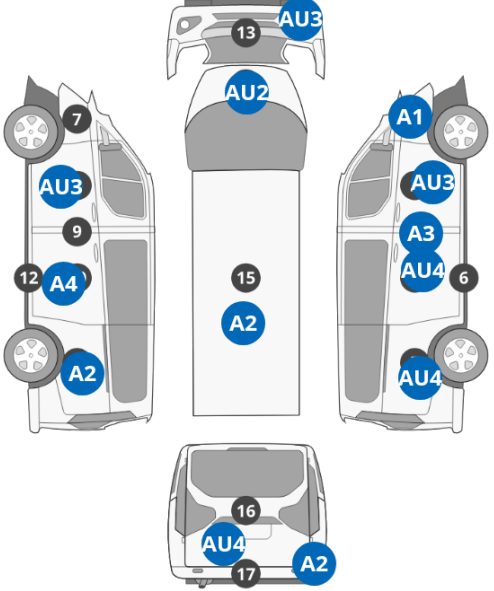
<p><b>A</b> : Scratch <b>AU</b> : Scratch &amp; Dent <b>B</b> : Modified <b>C</b> : Corrosion <b>G</b> : Stone chip <b>P</b> : Faded <b>S</b> : Rust <b>SC</b> : Rust &amp; Corrosion <b>U</b> : Dent <b>X</b> : Defective <b>Y</b> : Crack, Gap</p>
<b>Remarks</b> (L) Front Seat - Grime - Medium / (R) Front Seat - Grime - Small / Dashboard - Worn, Scratch, Cut, Crack - Small / (R) Front Trim - Grime - Small / Rear Seat - Grime - Medium / Trunk Room - Worn, Scratch, Cut, Crack - Medium / (L) Front Trim - Grime - Small / Ceiling - Grime - Small	<b>Remarks</b> (R) Front Door, Molding - Scratch & Dent - Medium / Bonnet, Headlight - Scratch & Dent - Small / (R) Front Fender, Molding - Scratch - Minimal / Front Bumper, Grille, Lamps - Scratch & Dent - Medium / (R) Center Panel - Scratch - Medium / (R) Rear Door, Molding - Scratch & Dent - Large / (R) Rear Fender, Molding - Scratch & Dent - Large / Rear Bumper, Lamps, Panels - Scratch - Small / Trunk Hood, Rear Gate - Scratch & Dent - Large / (L) Rear Door, Molding - Scratch - Large / (L) Front Door, Molding - Scratch & Dent - Medium / (L) Rear Fender, Molding - Scratch - Small / Roof - Scratch - Small
