## General Information

Date & Time: 10, Oct, 2025 16:07

<b>Make</b>	Mitsubishi	<b>Model</b>	Mirage
<b>YOM</b>	2023	<b>Odo Meter Reading</b>	22,533
<b>Registration No.</b>	LAL3124	<b>Chassis No.</b>	PAEA13TJPNA002802
<b>CC</b>	1.2	<b>Transmission</b>	A/T
<b>Fuel Type</b>	Gas	<b>Type of Body</b>	Sedan
<b>Colour</b>	Gray

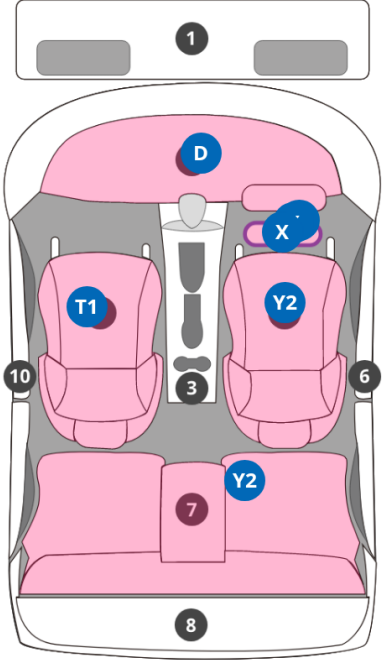
<b>Interior Evaluation :</b> <span style="float: right;"><b>B</b></span>	<b>Exterior Evaluation :</b> <span style="float: right;"><b>B</b></span>

<p><b>Inspector Notes</b></p>
<p>With LTO plate and warranty booklet, No Tools and Jack and Sparetire, No spare key, worn tires, adhesive marks, No reverse camera, foul smell., scratch front Windshield.</p>

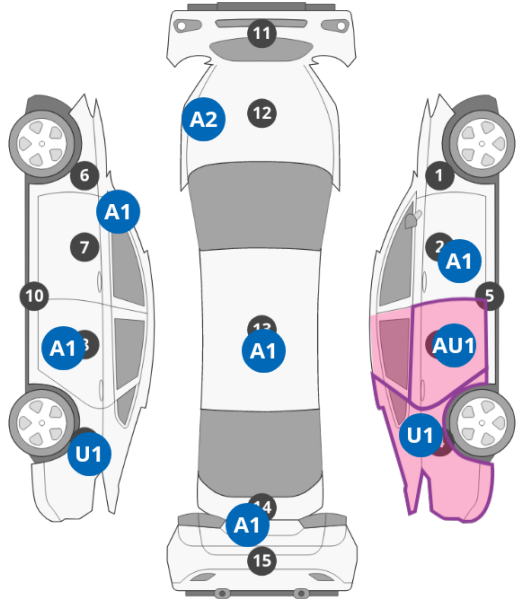
<p><b>A</b> : Scratch <b>AU</b> : Scratch &amp; Dent <b>B</b> : Modified <b>C</b> : Corrosion <b>G</b> : Stone chip <b>P</b> : Faded <b>S</b> : Rust <b>SC</b> : Rust &amp; Corrosion <b>U</b> : Dent <b>X</b> : Defective <b>Y</b> : Crack, Gap</p>
<p><b>Remarks</b> Dashboard - Traces of Adhesive Tape - Yes / (L) Front Floor Mat - Missing - Yes / (R) Front Floor Mat - Missing - Yes / Mat Other - Missing - Yes / Rear Seat - Grime - Small / (R) Front Seat - Grime - Small / (L) Front Seat - Cigarette Burns - Burnt Minimal</p>	<p><b>Remarks</b> (R) Rear Fender - Repair Traces - Yes / (R) Rear Door - Repair Traces - Yes / (R) Rear Door, Molding - Repair mark - Yes / (R) Rear Fender, Molding - Repair mark - Yes / Bonnet, Headlight - Scratch - Small / (R) Rear Door, Molding - Scratch &amp; Dent - Minimal / (R) Rear Fender, Molding - Dent - Minimal / Trunk Hood, Rear Gate - Scratch - Minimal / (R) Front Door, Molding - Scratch - Minimal / (L) Rear Fender, Molding - Dent - Minimal / (L) Rear Door, Molding - Scratch - Minimal / (L) Mirror - Scratch - Minimal / Roof - Scratch - Minimal</p>
