## General Information

Date & Time: 27, Oct, 2025 12:58

<b>Make</b>	Toyota	<b>Model</b>	Vios
<b>YOM</b>	2023	<b>Odo Meter Reading</b>	31,612
<b>Registration No.</b>	DBB5788	<b>Chassis No.</b>	PA1B18F30P4202883
<b>CC</b>	1.3	<b>Transmission</b>	CVT
<b>Fuel Type</b>	Gas	<b>Type of Body</b>	Sedan
<b>Colour</b>	Black

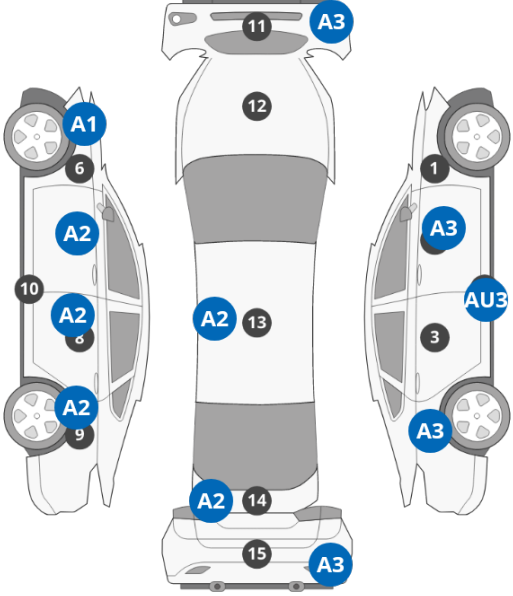
<p><b>A</b> : Scratch <b>AU</b> : Scratch &amp; Dent <b>B</b> : Modified <b>C</b> : Corrosion <b>G</b> : Stone chip <b>P</b> : Faded <b>S</b> : Rust <b>SC</b> : Rust &amp; Corrosion <b>U</b> : Dent <b>X</b> : Defective <b>Y</b> : Crack, Gap</p>
<p><b>Remarks</b> Ceiling - Grime - Small / (R) Front Floor Mat - Missing - Yes / (L) Front Floor Mat - Missing - Yes / Mat Other - Missing - Yes / (R) Front Trim - Grime - Medium / (R) Front Seat - Grime - Medium / Rear Seat - Grime - Large / (L) Front Trim - Grime - Medium / (L) Front Seat - Grime - Medium</p>	<p><b>Remarks</b> (L) Front Door, Molding - Scratch - Small / (L) Rear Fender, Molding - Scratch - Small / (L) Rear Door, Molding - Scratch - Small / (L) Front Fender, Molding - Scratch - Minimal / Trunk Hood, Rear Gate - Scratch - Small / (R) Front Door, Molding - Scratch - Medium / (R) Step, In-panel, Side Spoiler - Scratch &amp; Dent - Medium / (R) Rear Fender, Molding - Scratch - Medium / Rear Bumper, Lamps, Panels - Scratch - Medium / Front Bumper, Grille, Lamps - Scratch - Medium / Roof - Scratch - Small</p>
