General Information

Make	Mitsubishi	Model	Xpander
YOM	2019	Odo Meter Reading	65,241
Registration No.	DAM4684	Chassis No.	MK2XNNC1WKN004513
CC	1.5	Transmission	M/T
Fuel Type	Gas	Type of Body	Wagon
Colour	Gray

Body / Panel Condition

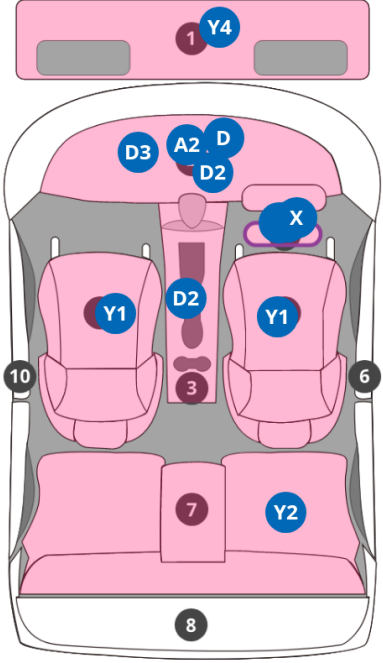
Interior Evaluation : C	Exterior Evaluation : D

<p>a : Cut, Fray d : Loose, Deformed k : Animal Hair s : Smell t : Cigarette Burns x : Defective y : Stain</p>

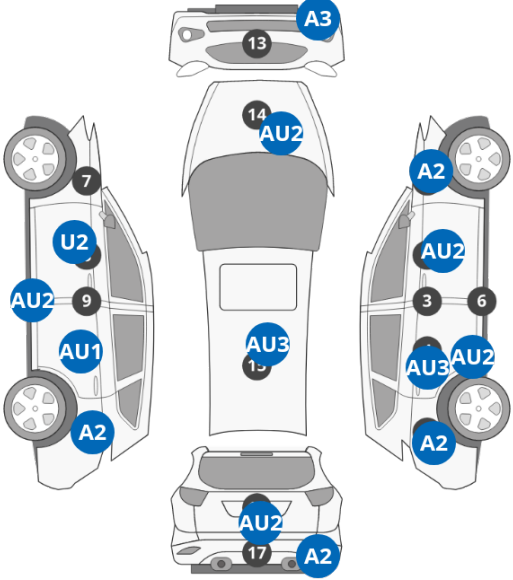
<p>A : Scratch AU : Scratch & Dent B : Modified C : Corrosion G : Stone chip P : Faded S : Rust SC : Rust & Corrosion U : Dent X : Defective Y : Crack, Gap</p>
<p>Remarks Ceiling - Grime - Large / Dashboard - Loose, Deformed - Medium / (R) Front Floor Mat - Missing - Yes / (L) Front Floor Mat - Missing - Yes / Mat Other - Missing - Yes / Instrument Panel - Worn, Scratch, Cut, Crack - Small / Dashboard - Traces of Adhesive Tape - Yes / Glove Box - Loose, Deformed - Small / (R) Front Seat - Grime - Minimal / (L) Front Seat - Grime - Minimal / Console, Switches, Vents - Loose, Deformed - Small / Rear Seat - Grime - Small</p>	<p>Remarks Trunk Hood, Rear Gate - Scratch & Dent - Small / (R) Rear Door, Molding - Scratch & Dent - Medium / (R) Step, In-panel, Side Spoiler - Scratch & Dent - Small / (R) Front Door, Molding - Scratch & Dent - Small / (R) Front Fender, Molding - Scratch - Small / Front Bumper, Grille, Lamps - Scratch - Medium / Bonnet, Headlight - Scratch & Dent - Small / (L) Front Door, Molding - Dent - Small / (L) Rear Door, Molding - Scratch & Dent - Minimal / (L) Rear Fender, Molding - Scratch - Small / (L) Step, In-panel, Side Spoiler - Scratch & Dent - Small / (R) Rear Fender, Molding - Scratch - Small / Rear Bumper, Lamps, Panels - Scratch - Small / Roof - Scratch & Dent - Medium</p>
