## General Information

<b>Make</b>	Toyota	<b>Model</b>	Innova
<b>YOM</b>	2020	<b>Odo Meter Reading</b>	70,956
<b>Registration No.</b>	CBL2973	<b>Chassis No.</b>	PA2JA8EM9L0081662
<b>CC</b>	2.8	<b>Transmission</b>	A/T
<b>Fuel Type</b>	Diesel	<b>Type of Body</b>	Wagon
<b>Colour</b>	Red Mica Metallic

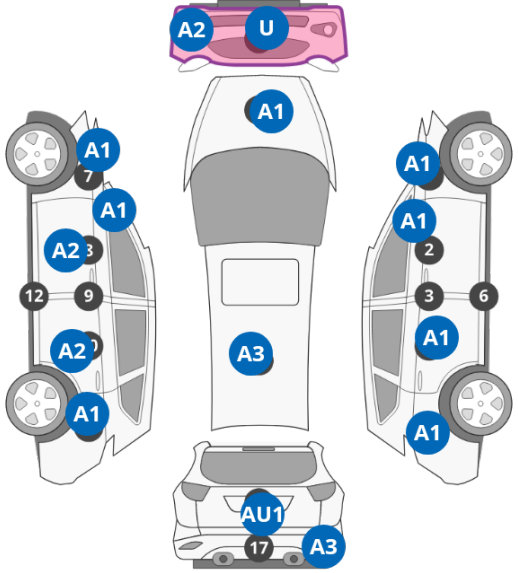
<p><b>A</b> : Scratch <b>AU</b> : Scratch &amp; Dent <b>B</b> : Modified <b>C</b> : Corrosion <b>G</b> : Stone chip <b>P</b> : Faded <b>S</b> : Rust <b>SC</b> : Rust &amp; Corrosion <b>U</b> : Dent <b>X</b> : Defective <b>Y</b> : Crack, Gap</p>
<p><b>Remarks</b> Ceiling - Grime - Small</p>	<p><b>Remarks</b> Member (Bolted) - Dent - Yes / Front Bumper, Grille, Lamps - Repair mark - Yes / Front Bumper, Grille, Lamps - Scratch - Small / (R) Front Fender, Molding - Scratch - Minimal / (R) Mirror - Scratch - Minimal / (R) Rear Door, Molding - Scratch - Minimal / (R) Rear Fender, Molding - Scratch - Minimal / Rear Bumper, Lamps, Panels - Scratch - Medium / Trunk Hood, Rear Gate - Scratch &amp; Dent - Minimal / (L) Rear Fender, Molding - Scratch - Minimal / (L) Rear Door, Molding - Scratch - Small / (L) Front Door, Molding - Scratch - Small / Bonnet, Headlight - Scratch - Minimal / Roof - Scratch - Medium / (L) Mirror - Scratch - Minimal / (L) Front Fender, Molding - Scratch - Minimal</p>
