## General Information

| <b>Make</b> | Toyota | <b>Model</b> | Vios |
| <b>Registration No.</b> | DBH7447 | <b>Chassis No.</b> | PA1B18F3XP4209128 |

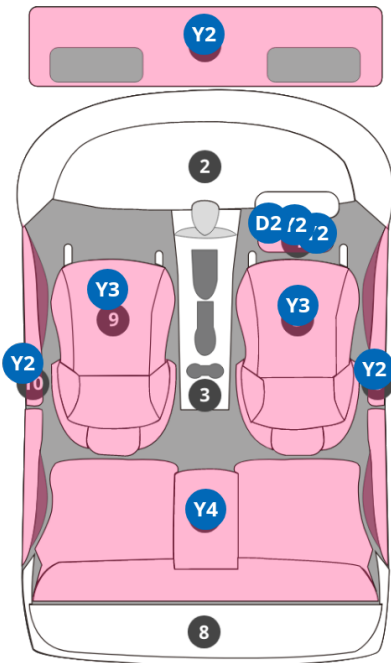
| <p><b>Remarks</b><br/>Ceiling - Grime - Small / (R) Front Trim - Grime - Small / (R) Front Seat - Grime - Medium / (R) Front Floor Mat - Grime - Small / Rear Seat - Grime - Large / Mat Other - Grime - Small / (L) Front Trim - Grime - Small / (L) Front Seat - Grime - Medium / (L) Front Floor Mat - Worked - Small</p> | <p><b>Remarks</b><br/>(L) Front Door, Molding - Scratch &amp; Dent - Medium / (L) Step, In-panel, Side Spoiler - Scratch - Small / (L) Mirror - Scratch - Small / Front Bumper, Grille, Lamps - Scratch &amp; Dent - Large / (R) Front Fender, Molding - Scratch - Medium / (R) Front Door, Molding - Scratch - Small / (R) Rear Door, Molding - Scratch - Small / (R) Step, In-panel, Side Spoiler - Scratch - Small / Trunk Hood, Rear Gate - Scratch - Small / Rear Bumper, Lamps, Panels - Scratch - Small</p> |
