## General Information

<b>Make</b>	Toyota	<b>Model</b>	Vios
<b>YOM</b>	2024	<b>Odo Meter Reading</b>	13,780
<b>Registration No.</b>	DBO2376	<b>Chassis No.</b>	PA1B18F35P4236656
<b>CC</b>	1.3	<b>Transmission</b>	CVT
<b>Fuel Type</b>	Gas	<b>Type of Body</b>	Sedan
<b>Colour</b>	Silver

## Body / Panel Condition

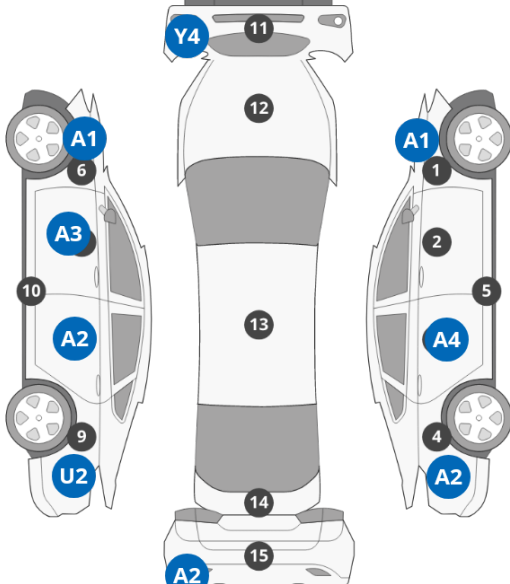
<p><b>A</b> : Scratch <b>AU</b> : Scratch &amp; Dent <b>B</b> : Modified <b>C</b> : Corrosion <b>G</b> : Stone chip <b>P</b> : Faded <b>S</b> : Rust <b>SC</b> : Rust &amp; Corrosion <b>U</b> : Dent <b>X</b> : Defective <b>Y</b> : Crack, Gap</p>
<p><b>Remarks</b> (L) Front Trim - Grime - Small / Ceiling - Grime - Minimal</p>	<p><b>Remarks</b> (L) Rear Fender, Molding - Dent - Small / Front Bumper, Grille, Lamps - Crack, Gap - Large / (R) Front Fender, Molding - Scratch - Minimal / (R) Rear Door, Molding - Scratch - Large / (R) Rear Fender, Molding - Scratch - Small / Rear Bumper, Lamps, Panels - Scratch - Small / (L) Front Fender, Molding - Scratch - Minimal / (L) Front Door, Molding - Scratch - Medium / (L) Rear Door, Molding - Scratch - Small</p>
